## Coal fired Castle Peak Power Station in Hong Kong modifies 250 m reinforced concrete chimney with four steel flues

CLP Power, a subsidiary of China Light & Power, is the leading supplier of electricity in Hong Kong. CLP Power’s Castle Peak Power Station (figure 1), one of the largest coal firing power stations in the world, has four 677 MW units that were commissioned between 1985 and 1989. Running at over 38% efficiency at full load, the Castle Peak B units are a key generating asset for the Hong Kong economy.

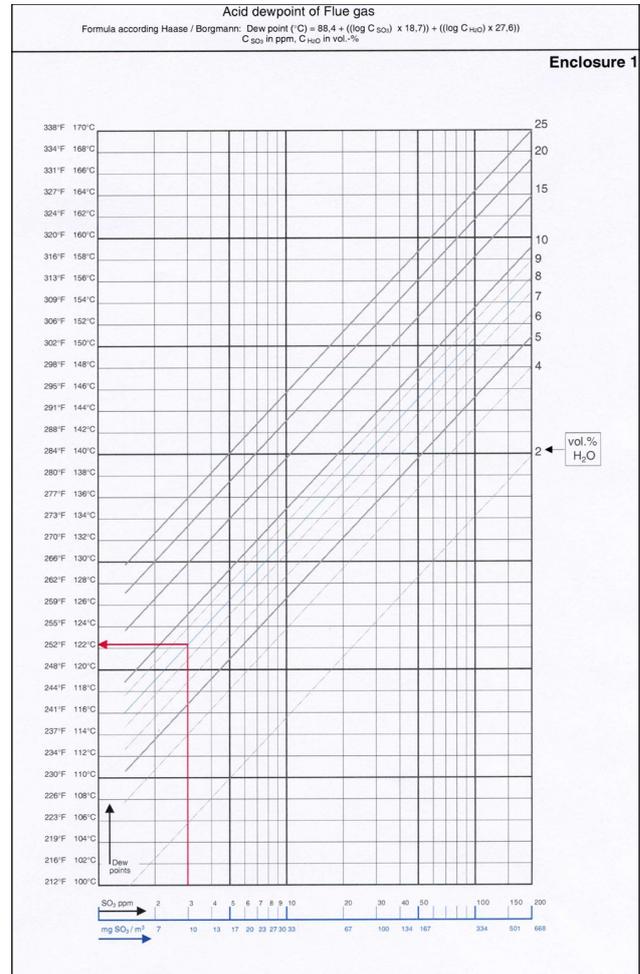
**Graph 1: Determination of sulphuric acid dewpoint according to Haase-Borgmann formula**

Borgmann formula. For a flue gas with 10 mg/Nm<sup>3</sup> SO<sub>2</sub> and 8 % water, the expected acid dewpoint will be 122°C. The flue gas temperature in the steel flues will therefore be 40°C under sulphuric acid dewpoint.

With the FGD working, the treated flue gas will be reheated by Gas-to-Gas heaters to 80°C. Graph 1 shows the determination of the sulphuric acid dewpoint according to the Haase-

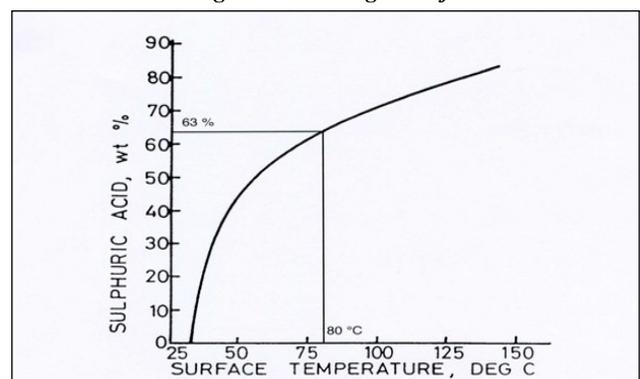
**Graph 2: Variation of condensed sulphuric acid concentration with temperature**

Graph 2 shows the relation between the temperature and the concentration of condensed sulphuric acid.

With a flue gas temperature of 80°C, the estimated concentration of sulphuric acid will be 63 %. The sulphuric acid concentration will be highly corrosive. The flues must be lined to resist the corrosive conditions.

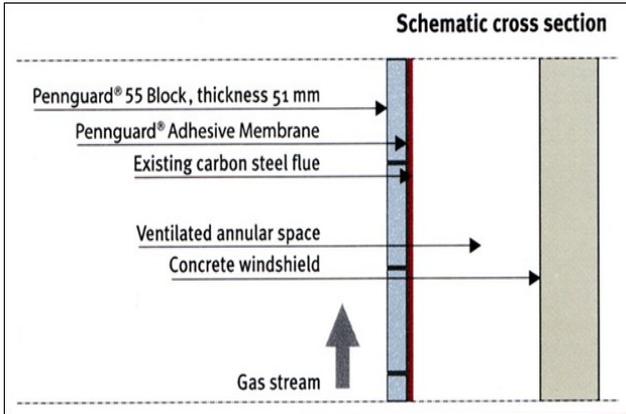
**Graph 3: Schematic cross section of the Pennguard lined steel flues**

Following an evaluation of different chimney flue lining technologies, CLP Power selected the Pennguard Block Lining System, using 51 mm thick Pennguard Block 55 (Graph 3). The Pennguard linings were installed in all four flues during planned boiler outages, each about 70 days long, in 2008, 2009 and 2010.

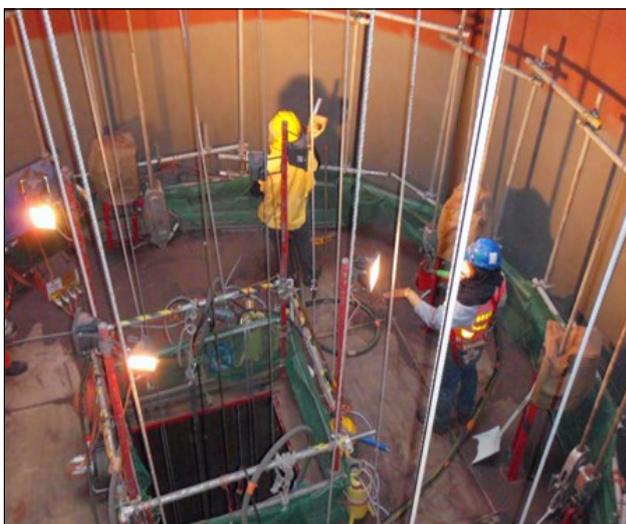
**Figure 2: Work platform, separate hoist for lining materials**

A strong platform, with a full floor and a fast, separate hoist for materials supply was built, to ensure optimum access to all steel surfaces, as well as an uninterrupted supply of Pennguard materials to the installation crews (figure 2). The top of the chimney was sealed off with a temporary roof (figure 3).

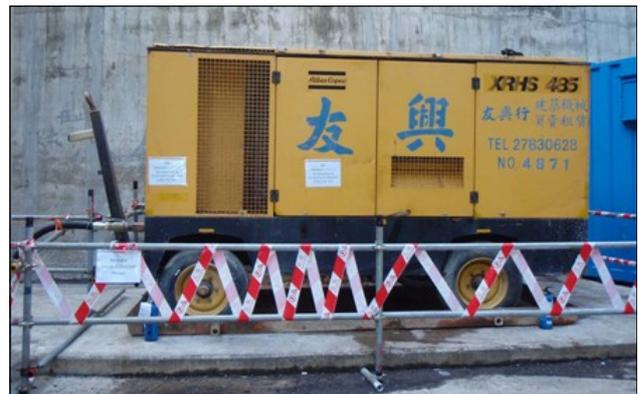
**Figure 3: 336 m<sup>3</sup>/hour compressor**

Gritblasting up to 250 m high was made possible by a single 336 m<sup>3</sup>/hour compressor (figure 4) placed on ground level, with 3 blast pots placed on the support floors within the chimney windshield.

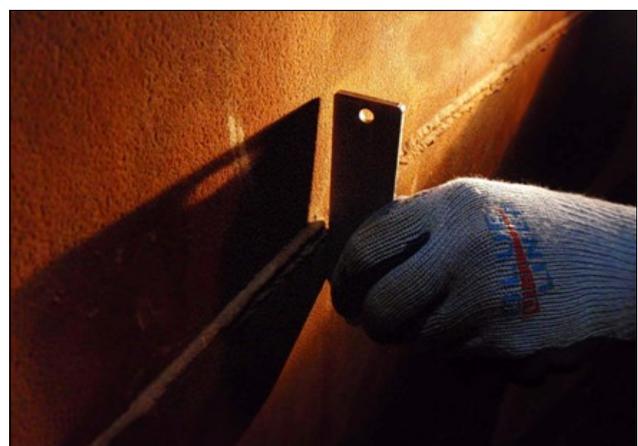
**Figure 4: Protruding welds and slight roughness in used steel flues are acceptable for the Pennguard Block Lining System**

Pennguard linings offer a great advantage for lining used steel flues that were not originally fabricated as “fit-for-lining” (figure 4) : small imperfections in welds, such as rip-

ples, protrusions and pinholes can be left uncorrected and even slight pitting in the steel plate is not a problem.

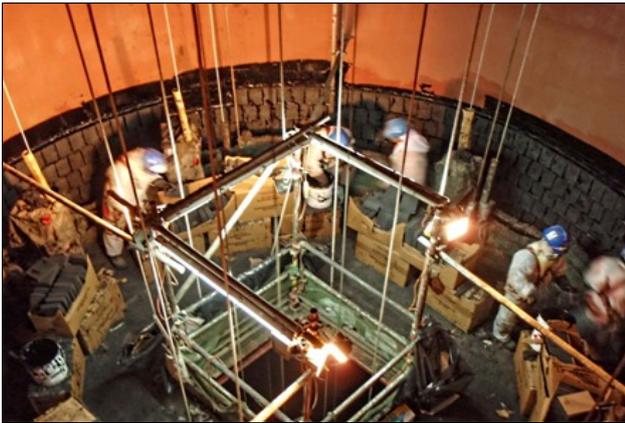
Figure 5: Pennguard lining installation

The Pennguard lining installation work was performed by two teams, each with 8 trained brick layers, working in two shifts per 24 hours (figure 5). The typical productivity per day was 250 m<sup>2</sup>.

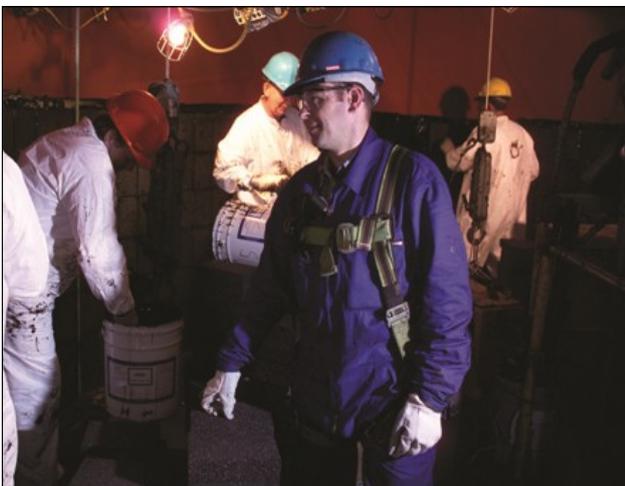
Figure 6: All works were supervised by Hadek QA Inspectors

All works were supervised by Hadek QA Inspectors (figure 6). One QA Inspector attended during surface preparation. During installation of the Pennguard lining, one Inspector was present during the day shift and a second Inspector worked during the night shift. As on most Pennguard lining projects, Hadek performed intensive, systematic QA Supervision, allowing any defects to be identified and corrected immediately.

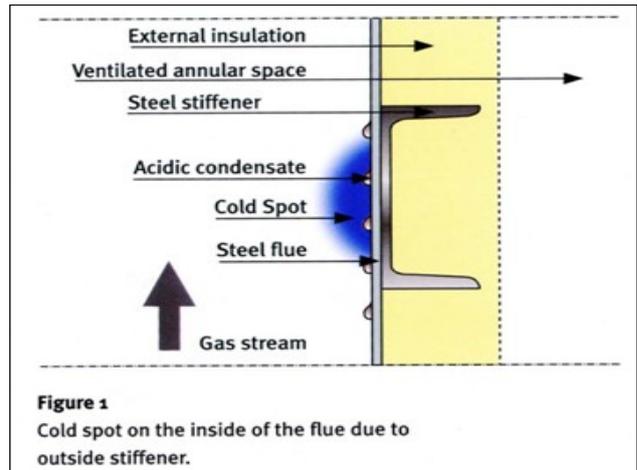
Graph 4: Situation prior to Pennguard lining installation and removal of external insulation

For structural stability as well as for construction purposes, every steel chimney / steel chimney flue has stiffeners on its outside. In these areas, the steel is much thicker than the standard plate thickness and it is often difficult to apply an effective thermal insulation.

These stiffeners generate “cold spots” on the inside of the chimney flue, where excessive condensate formation can take place especially during start-ups and low load operation (graph 4).

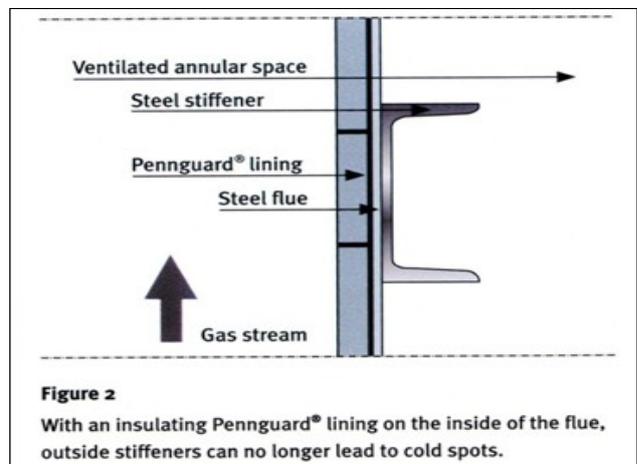
Graph 5: Situation following Pennguard installation and removal of external insulation

The use of thermally insulating Pennguard linings on the inside of steel flues eliminates this problem. The Pennguard lining system will provide effective thermal insulation in all areas of the flue, even where the outside flue surface is covered with external stiffeners (graph 5).
