Operating performance of Pennguard® lined steel flues in FGD Wet Stacks in the United States and Canada

Case 1: Coleson Cove Generating Station, St John, NB-Canada

**Case 2:
Spurlock Power Station, Maysville, KY**

**Case 3:
Mayo Power Station, Roxboro, NC**

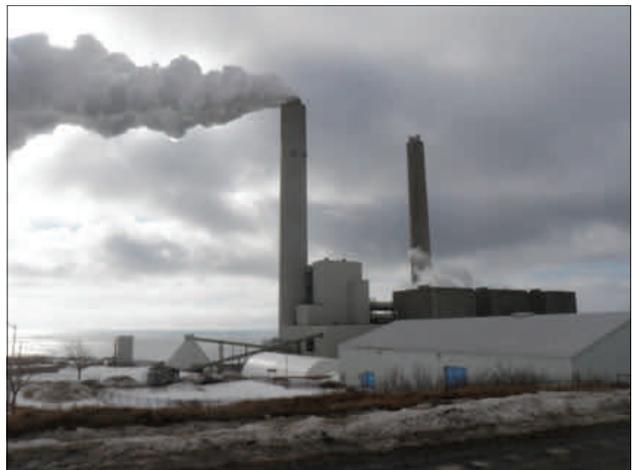
Picture 1 - Coleson Cove Generating Station, Canada

The Coleson Cove Generating Sta-tion (picture 1) is owned and operated by New Brunswick Power and consists of 3 units of 350 MW each. In conjunction with the retrofit of a WFGD plant in 2004, a new chim-ney with 2 steel flues was constructed and a 2" thick Pennguard Block Lining System was installed to protect the steel chimney flues. The lining system was installed in phases between March and Septem-ber 2004.

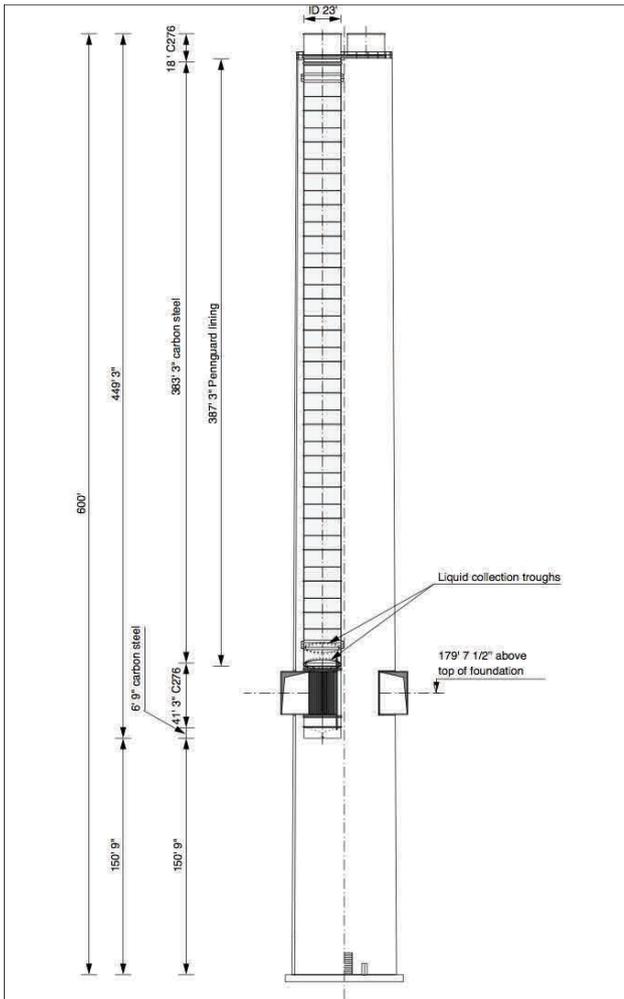
Figure 1 - Chimney layout

The Pennguard lining in both flues starts at EL. 196'-9" and terminates at EL. 584', a total of approximately 56,000 ft² steel surface is protected by the Pennguard Block Lining System (see figure 1).

At several locations throughout both flues, Liquid Collection systems have been installed to trap the condensate and move it out of the chimney flue. The outside of both flues is not insulated as the Pennguard lining system is not only a corrosion barrier, but also a strong thermal insulator. The chimney flue gas temperature within both flues is between approximately 130°F, the flue gas velocity is approximately 60 ft/sec.

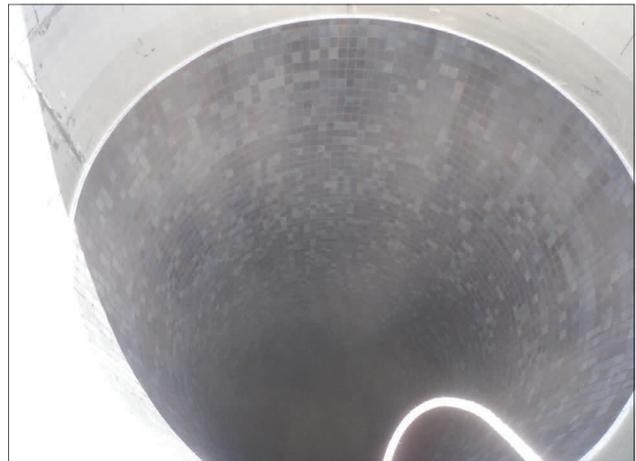
Over the years, several visual inspections were carried out to monitor the performance of the Pennguard Block Lining System. The inspections showed that the Pennguard lining system fully protected the steel flues from corrosion, while acidic condensate was running down the insides of the flues continuously.

**Picture 2 - Coleson Cove Power Station:
top view of the Pennguard lining system in one of the
2 flues after being in service for 10 years**

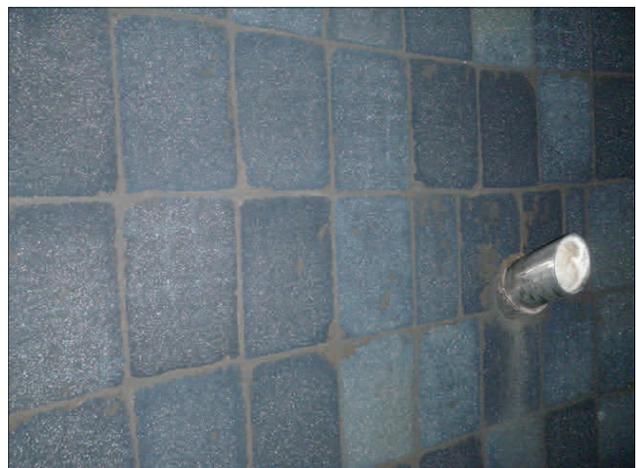
**Picture 3 - Coleson Cove Power Station:
Condition of the Pennguard lining system in detail**

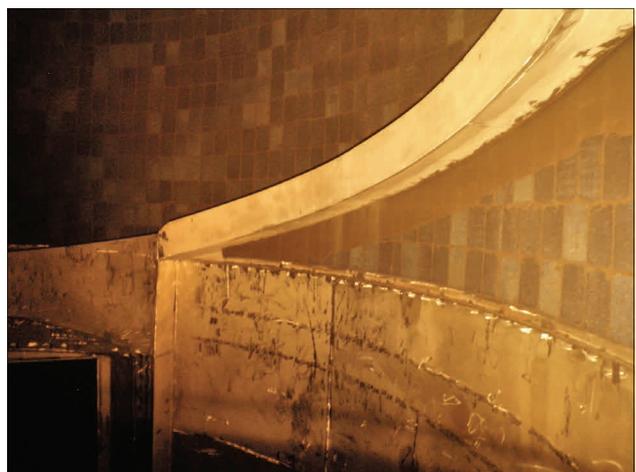
**Picture 4 - Coleson Cove Power Station:
This picture is showing the Pennguard lining system as
well as a liquid collection gutter detail
after 10 years of operation**

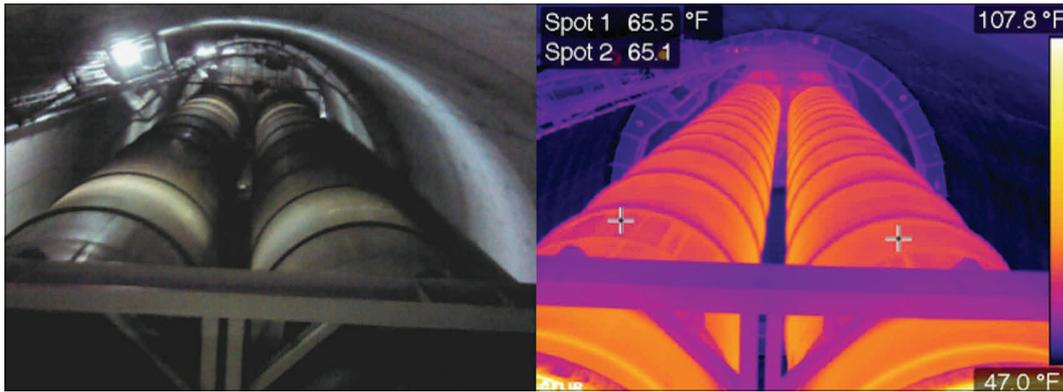
Picture 5 - Coleson Cove Power Station: Overview of the 2 steel chimney flues

possible to find it by a normal visual inspection, modern Thermal Imaging technology will readily show any such area. Pictures 5 – 7 were taken in the Coleson Cove chimney and clearly show how well the lining system performs. Please note that these units have been in service well over 10 years.

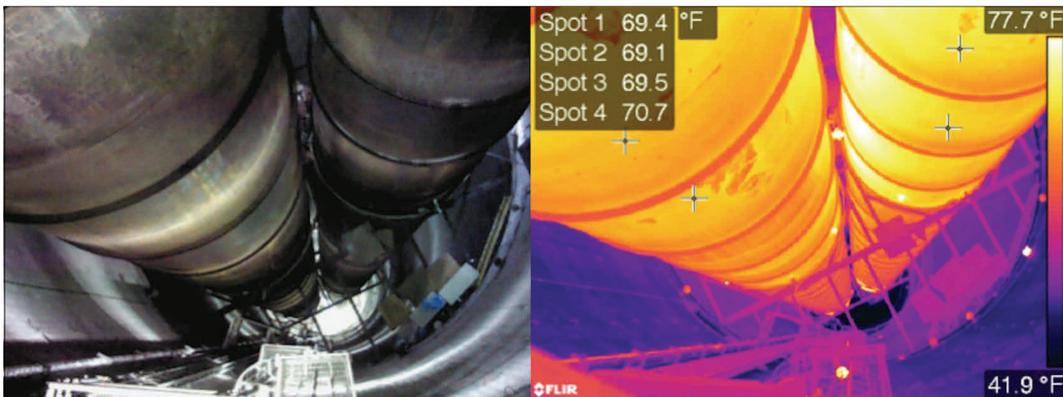
Picture 6 - Coleson Cove Power Station: Even heat distribution looking downwards

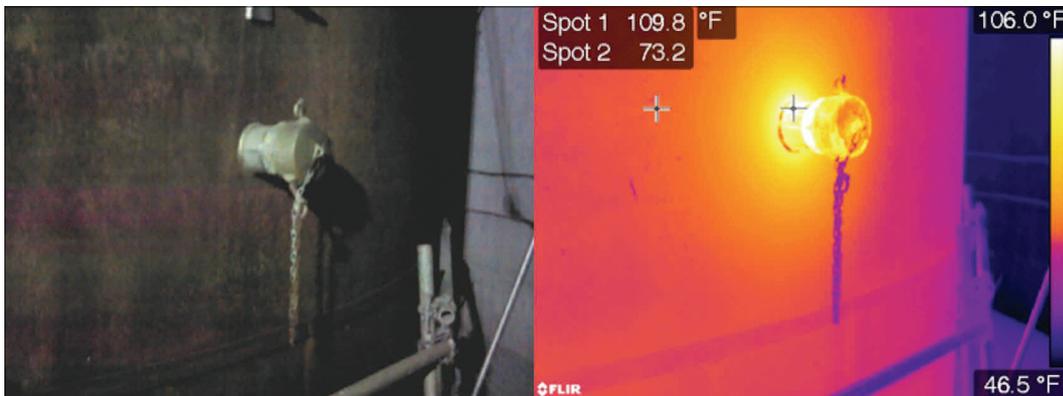
Picture 7 - Coleson Cove Power Station: Heat distribution around one of the CEMS ports

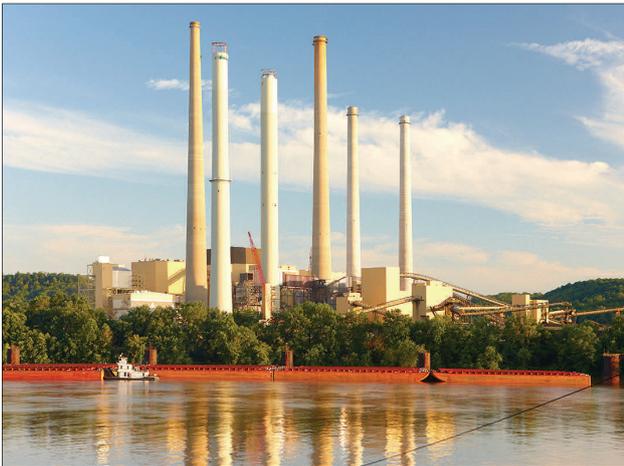
Picture 8 - Spurlock Power Station, Kentucky

#1 had a diameter of 21 ft, Unit #2 had a diameter of 27 ft. A total of approximately 87,511 ft² of steel flue surface was lined with the Pennguard Block Lining System, which was installed in phases between January and November 2008.

The Spurlock chimneys are FGD Wet Stacks carrying desulfurized, water saturated gas streams. The flue gas temperature in the chimney flues is between 125 and 130 °F. The flue gas velocity is less than 50 f/s.

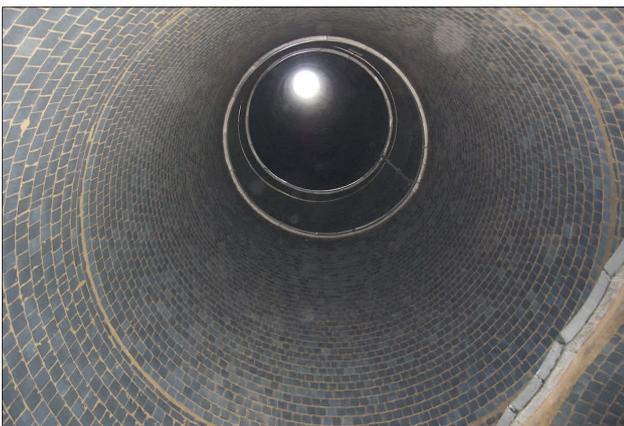
Since 2009, regular inspections have been carried out to inspect the performance of the Pennguard lining and except for some mechanical damages found around some of the drains and Liquid Collecting system, no repairs have been needed; the Pennguard lining is in excellent condition. It is apparent, when looking at the pictures 9-12, that both Units are operated very efficiently as there are no deposits to be seen on the flue walls.

Picture 9 - Spurlock PP: Unit #1: View upwards, excellent performance of the Pennguard Block Lining System

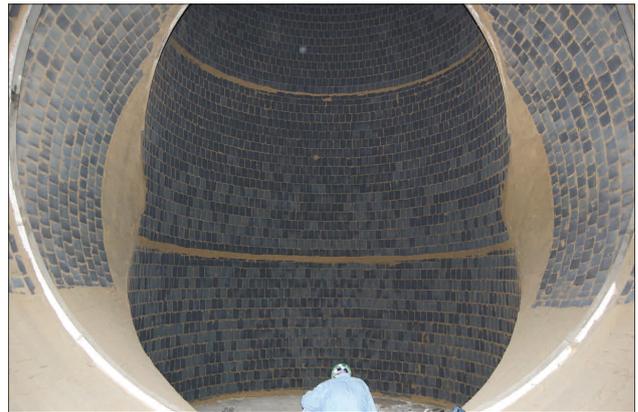
Picture 10 - Spurlock Power Station Unit#1: View towards chimney target wall area

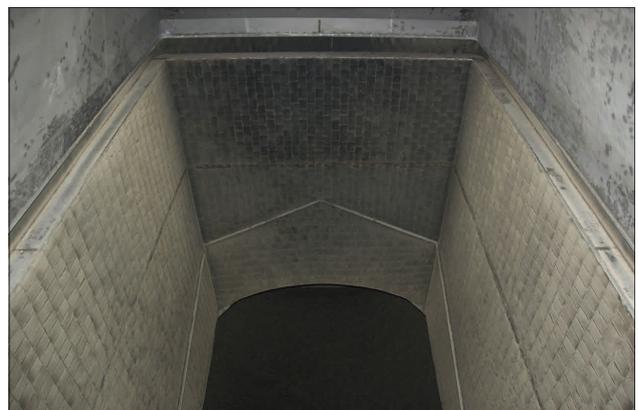
Picture 11 - Spurlock PP: Unit #2: View towards top of inlet (note the Liquid Collection gutters)

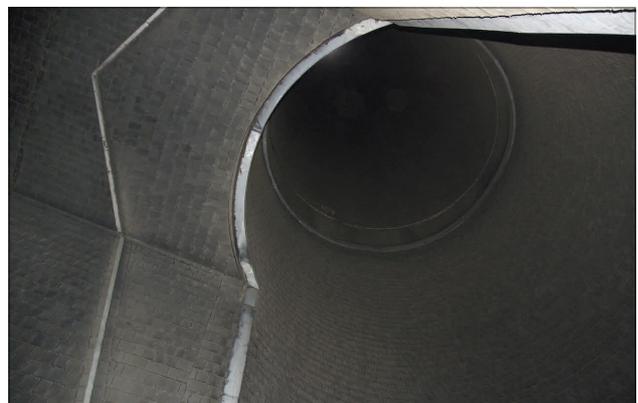
Picture 12 - Spurlock PP: Unit #2: Impression of the Pennguard Block Lining System around several Liquid Collector systems

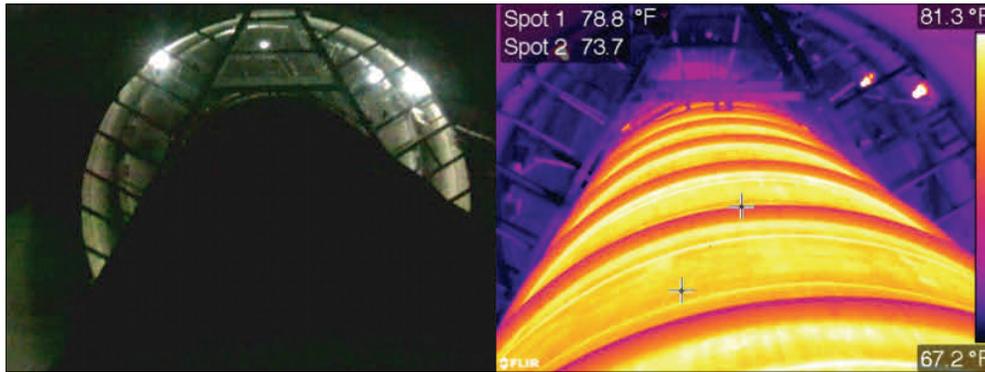
Picture 13 - Spurlock PP: Unit #1: Even heat distribution

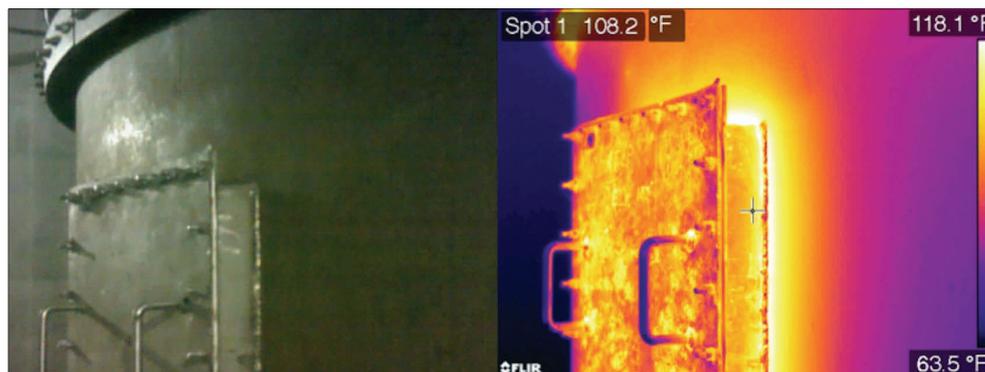
Picture 14 - Spurlock PP: Unit #1: Heat distribution around one of the inspection hatches

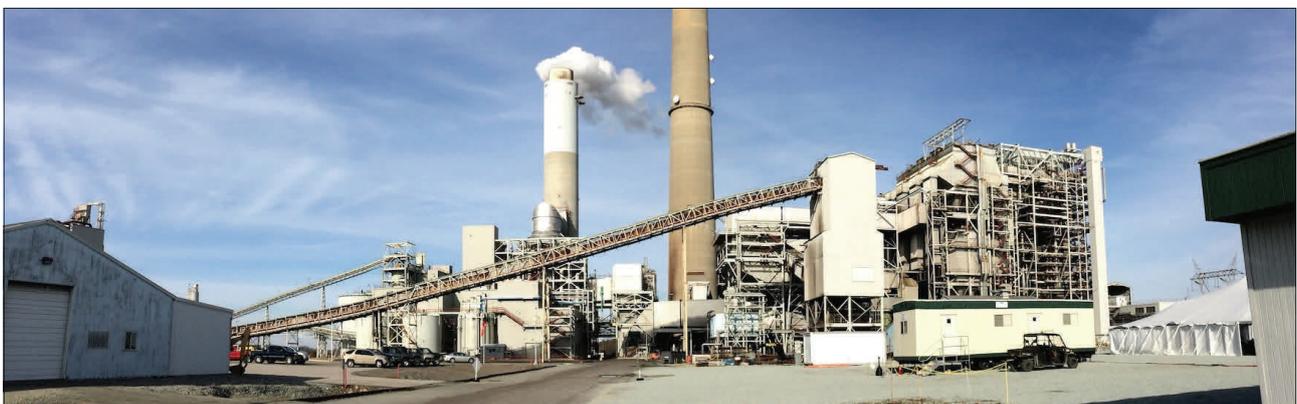
Picture 15 - Mayo Power Station, Roxboro

The Mayo Plant (picture 15) is a single unit, 727 MW coal-fired power plant, located near Roxboro, NC. It began commercial

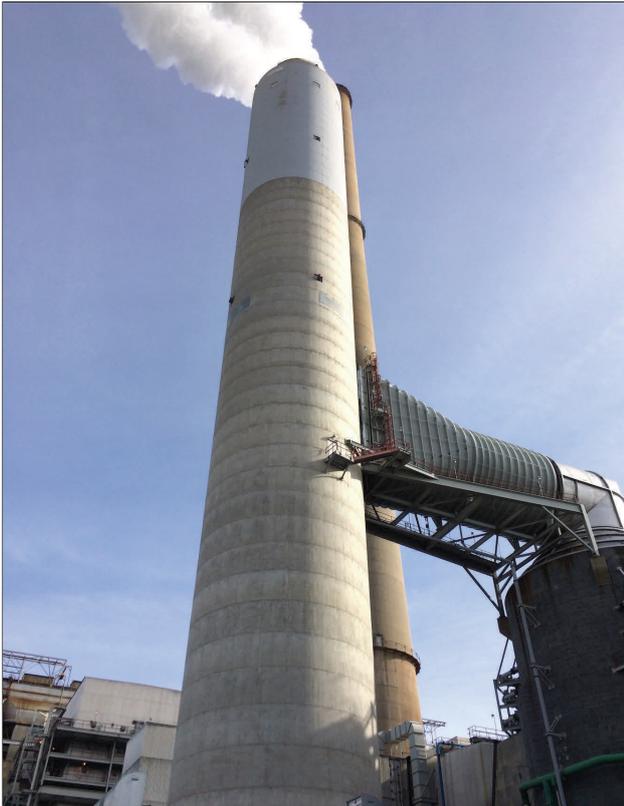
Picture 16 - Chimney of Mayo Power Station

The height of the concrete column is 360' (above foundation), the carbon steel flue has a total height of 255' and spans from the 125' level to the 380' level. The diameter of the steel flue is 30'-9" (constant). The breeching duct leading to the scrubber is 17' x 42'.

In September 2014, the plant awarded an independent consulting company a contract to perform a visual inspection of the entire chimney and its appurtenances. Part of the contract was to inspect the Pennguard lining.

It was found that after 6 years of operation with WFGD, the Pennguard lining was still in excellent condition. Apart from a small area (approximately 4' x 4') at a higher elevation where some blocks showed some scattered cracks, the Pennguard Lining did not require any repairs whatsoever. In the Spring of 2016, Hadek Protective Systems will have an opportunity to investigate the cause of these cracked blocks and replace them.

Based on the elevation where these cracked blocks were found we suspect that the flue liner may have moved in high winds during construction and may have touched the landing in the annular space. The surface of Pennguard lining shows a very thin layer of deposits but overall no issues were found and it is expected that the Pennguard lining system will protect the flue for many years to come.

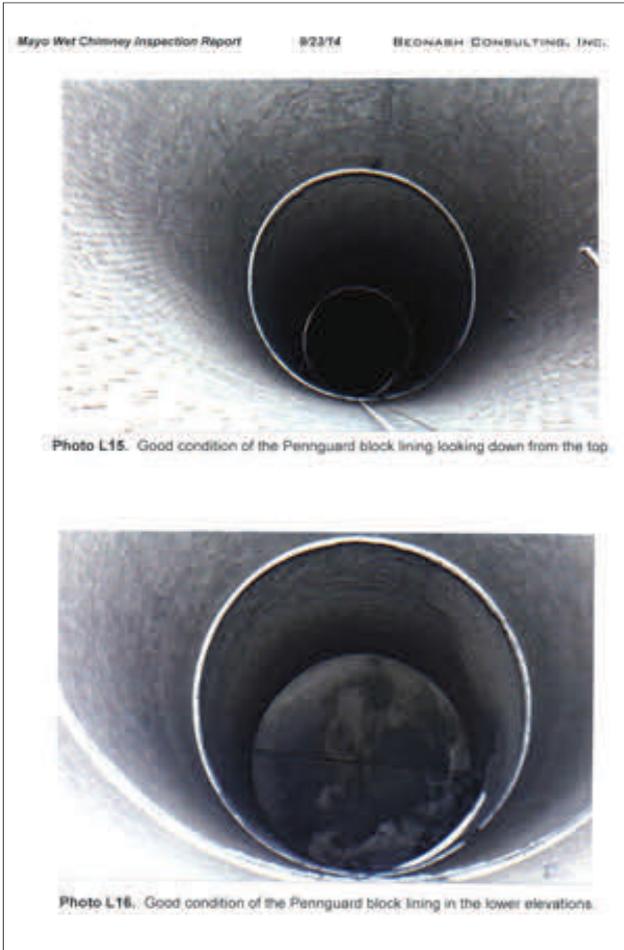
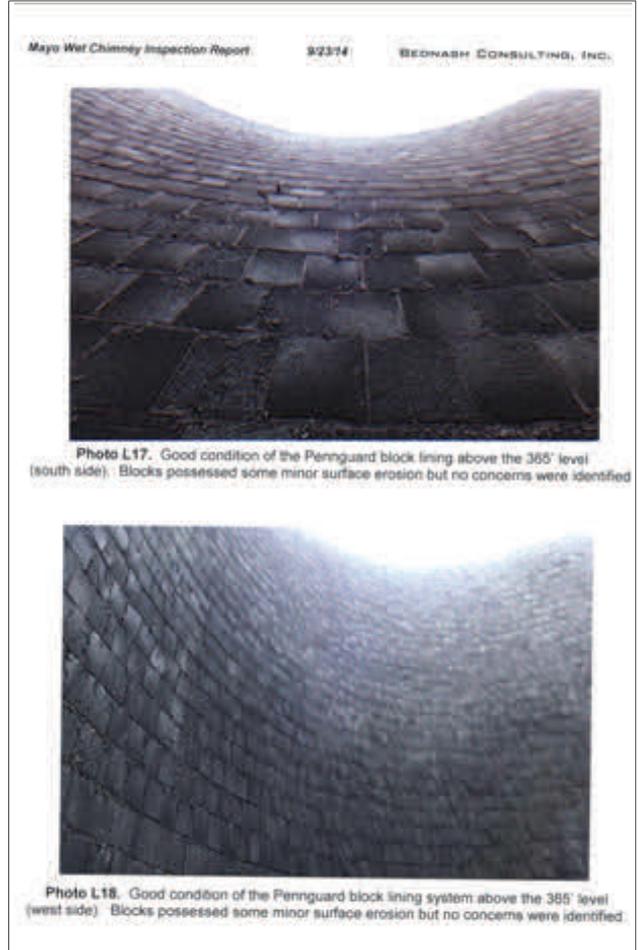
The pictures 17 and 18 provide an impression of the performance of the Pennguard lining seen during the September 2014 inspection (courtesy of Bednash Consulting, Inc.).

Pictures 17 and 18 - Mayo PP: Pictures showing the condition of the Pennguard chimney lining

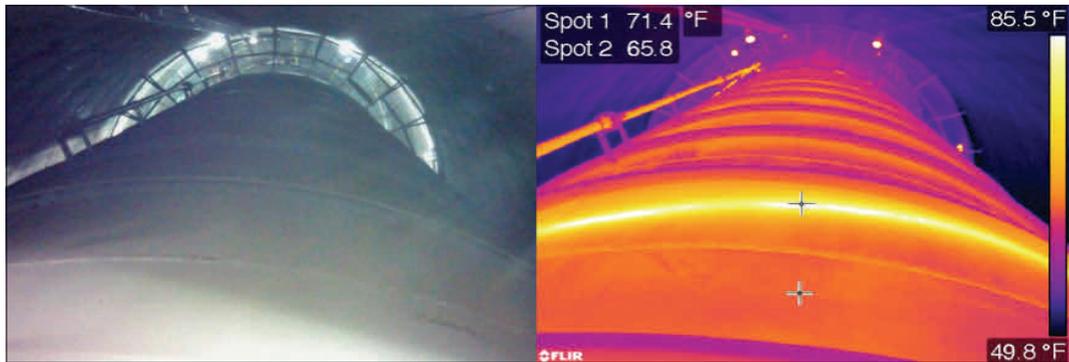
In February 2015, Hadek had the opportunity to enter the chimney annular space and examine the thermal insulating properties of the Pennguard lining using Thermal Imaging technology. It was found that the Pennguard lining kept the exterior steel temperature low compared to the wet flue gas temperature inside. No flaws in the insulating properties of the Pennguard Lining could be detected (pictures 19 – 20). As quoted by one of the engineers responsible for the chimney, "we love this stuff!!!"

Picture 19 - Mayo PP: Even heat distribution looking upwards

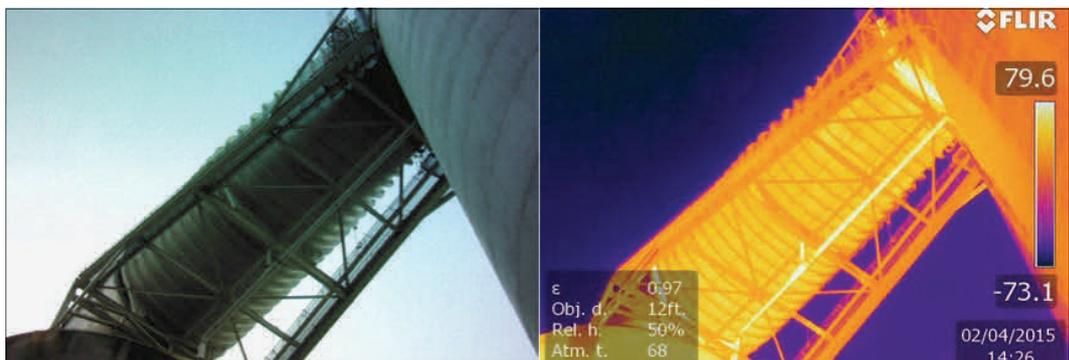
Picture 20 - Mayo PP: Even heat distribution inlet duct

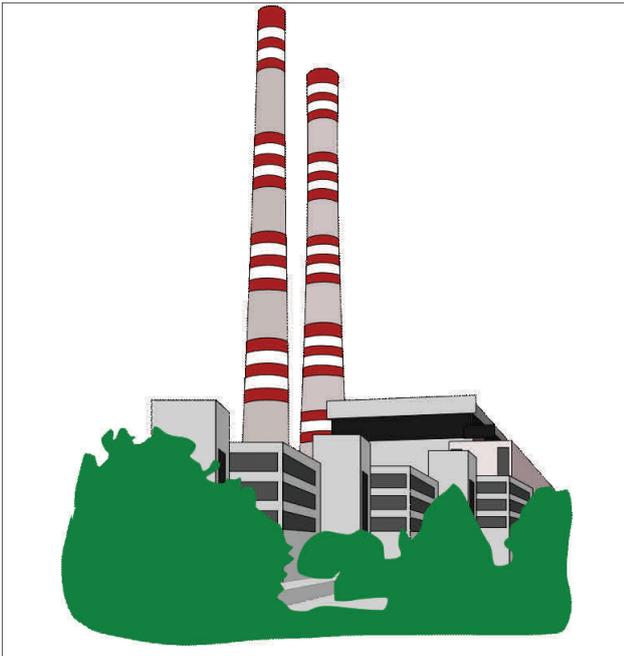
Picture 21 -
Design drawing lignite firing power plant in Texas

Each 800 MW unit has an identical concrete chimney with a single steel flue. These chimneys are 450' high and each has a 32'-10" diameter internal flue. Between October 2008 and May 2009, both flues were lined with the Pennguard Block Lining System, using 1.5" thick Pennguard Block 55. A total steel surface area of approximately 66,000 ft2 was protected with the Pennguard Block Lining System.

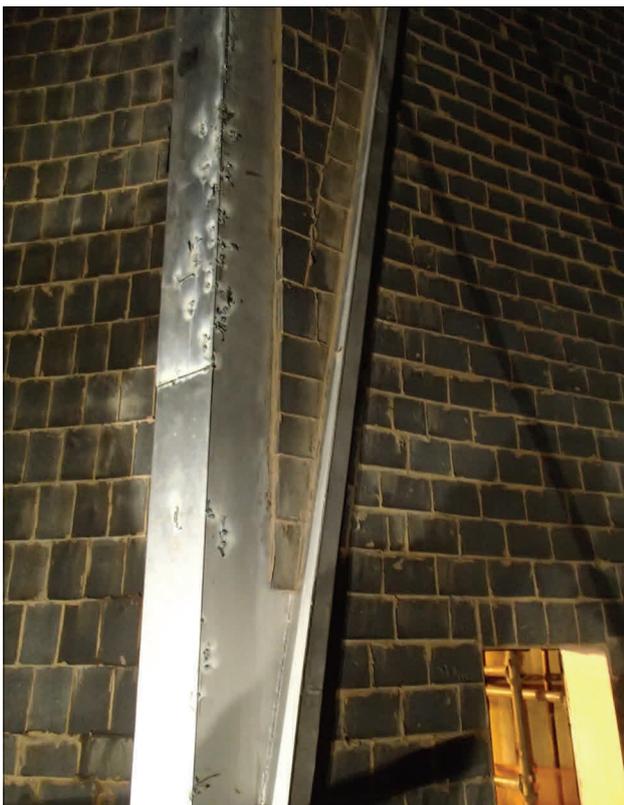
Between 2010 and 2015, as part of our 10 year warranty with the customer, several inspections were carried out in order to investigate the condition of the Pennguard Block Lining System and in each case the lining the lining was found to be in a very good condition; the Pennguard Block Lining System protected both chimneys very well against the aggressive flue gas and condensate. According to plant personnel, both units run almost full time with few starts and stops. Pictures 22 and 23 are taken during the most recent inspection in March 2015, showing the good condition of the lining.

Picture 22 - Good condition of the Pennguard lining at 800 MW lignite firing power plant in Texas

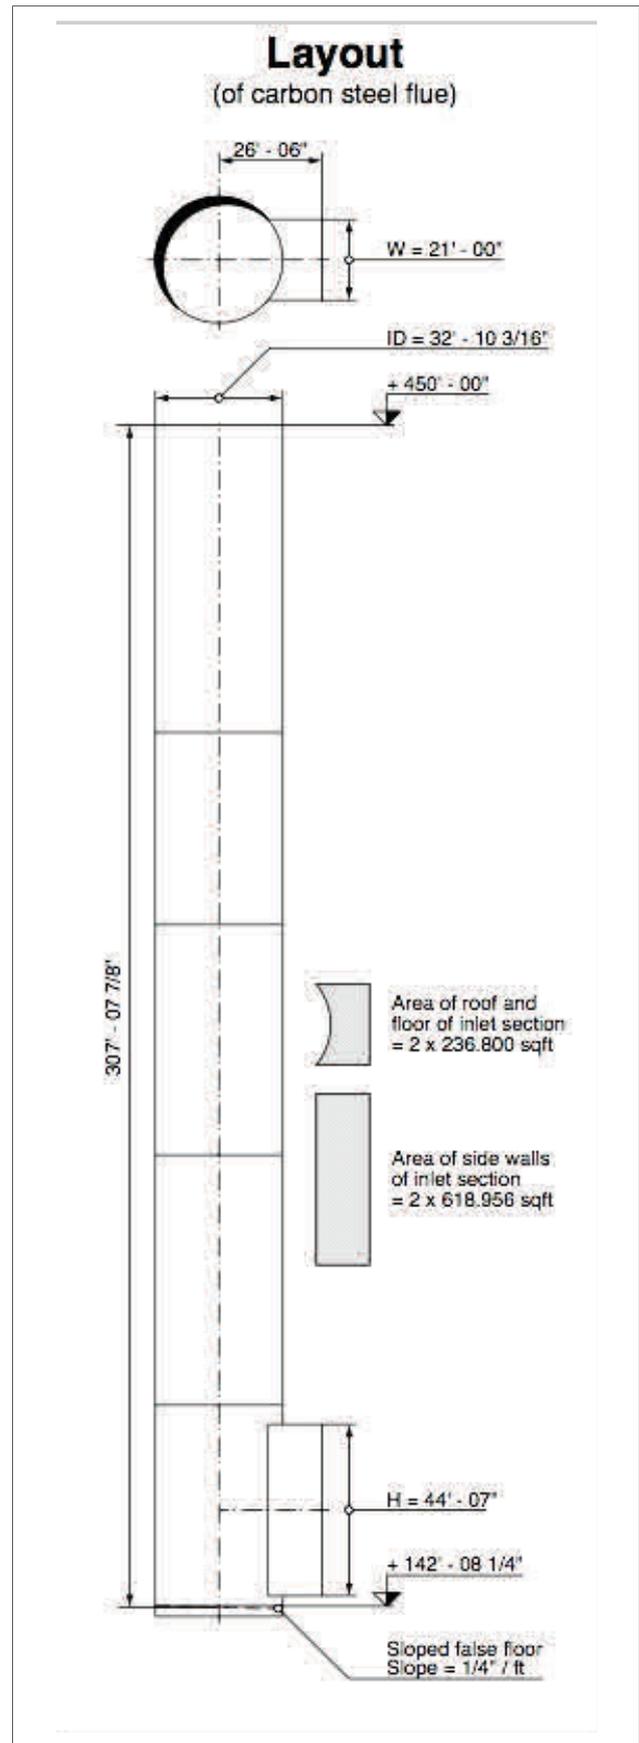
Figure 3 -
Chimney layout lignite firing power station in Texas

A C-276 Liquid Collection system was installed to trap liquid and discharge it through a drain system to the outside of the chimney flue. The operating temperatures are around 125 °F, the flue gas velocity, as confirmed by plant personnel, is 59.6 ft/sec.

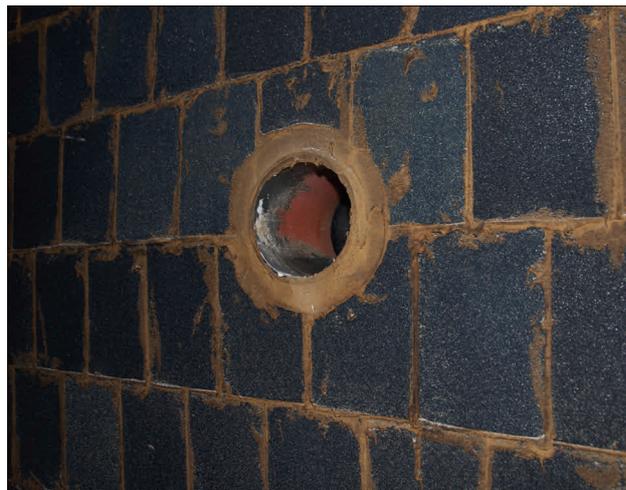
Picture 23 - This picture is showing the perfect condition of the Pennguard lining around nozzles at lignite firing power station in Texas.

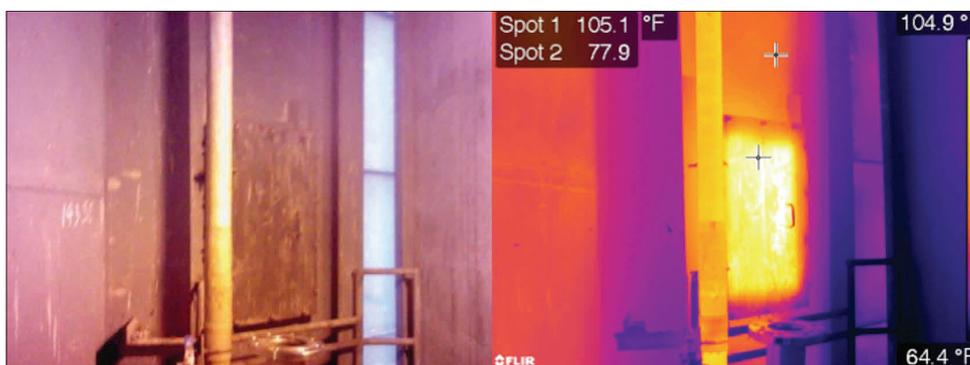
As in other projects, we have used Thermal Imaging technology (pictures 24 - 26) to monitor the thermal insulating capabilities of the installed Pennguard lining. I must

emphasize that the thermal images below were taken while one of the units was in start up mode and consequently they may not provide a 100% correct image. In this case these images are for illustration purposes only.

Picture 24 - Power Plant in Texas: Pennguard lined steel flue showing an even heat distribution

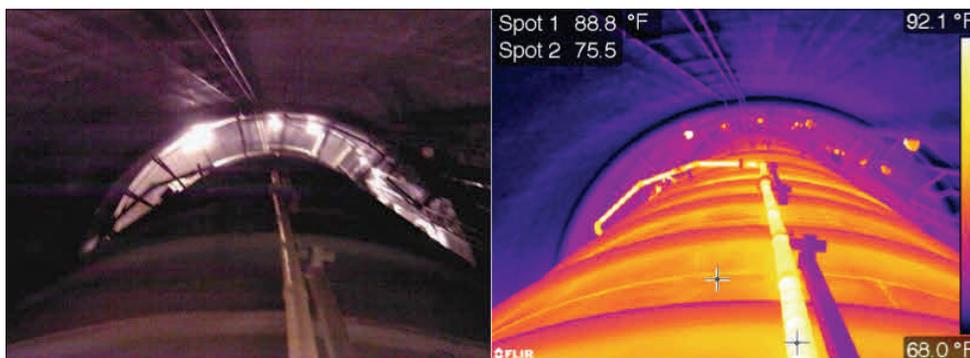
Picture 25 - Power Plant in Texas: Even heat distribution from bottom to top

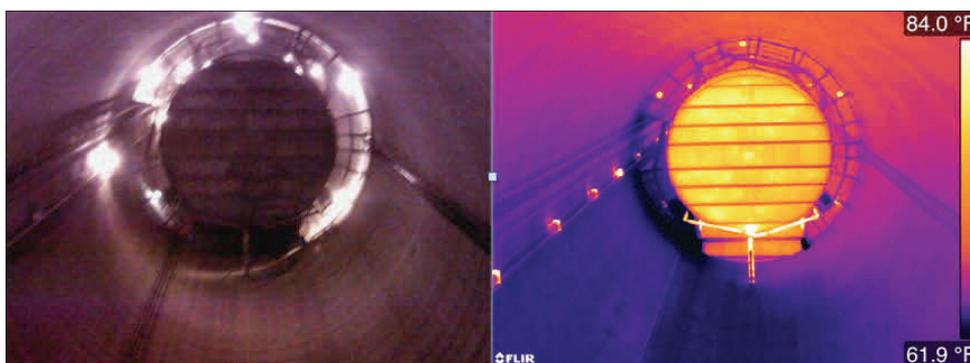
Picture 26 - Power Plant in Texas: Bottom of the Pennguard lined steel flue with an even heat distribution as well
