## Pennguard linings in free standing brick flues Three projects in the United States of America

### Introduction

This paper presents three cases from the recent past, where the owner had to install FGD plants and chose to re-use the existing chimney with independent brick flue. To protect the existing flue, the Pennguard Block Lining was used.

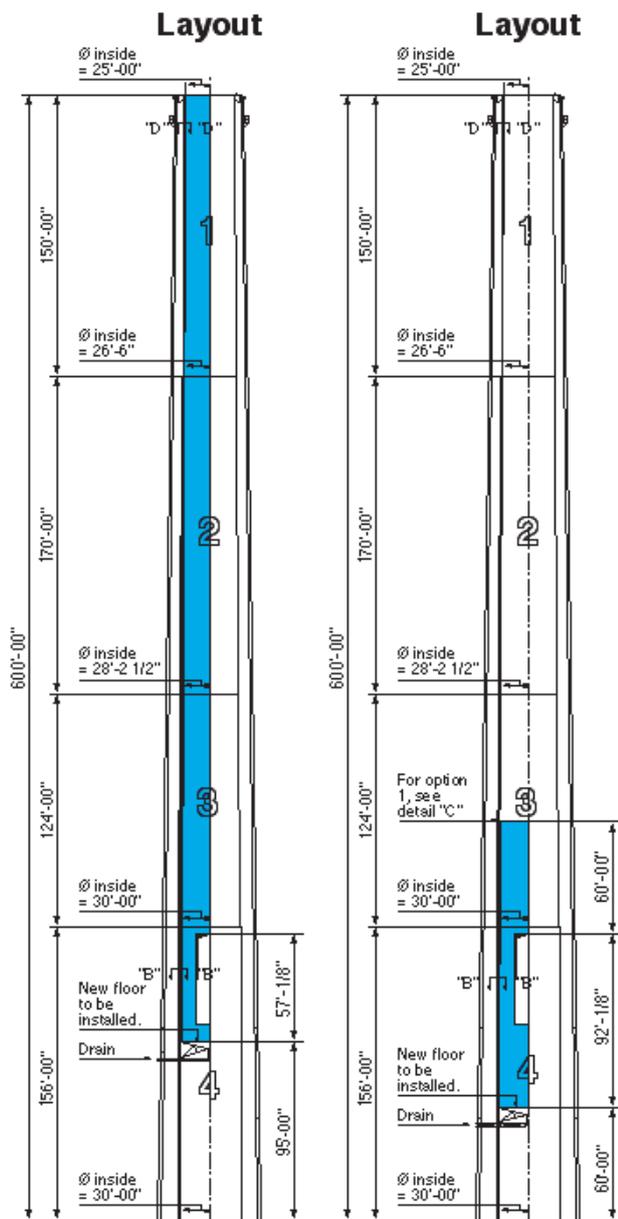
Figures 1 & 2: Option A and B: Partial lining vs Full height lining (Blue color indicates Penn-guard lining)

During the selection of a suitable lining for the existing flues of units 1 and 2, the owner had two options in mind. Option A: partial lining of the brick chimney flues with the Pennguard Block Lining System (up to 65 m) together with annulus pressurization (figure 1), and option B: lining of the brick chimney flues full height with the Pennguard Block Lining System (up to 183 m) (figure 2).

In-stead of two breechings, only one breech-ing was con-structed above the ex-ist-ing breech-ing open-ings. A false floor was in-stalled at ele-va-tion 29 m above da-tum and a liq-uid col-lection gut-ter in-stalled at ele-va-tion 65 m. Be-tween the floor and the gut-ter, the brick sub-strate was lined with the Penn-guard Block Lin-ing Sys-tem.

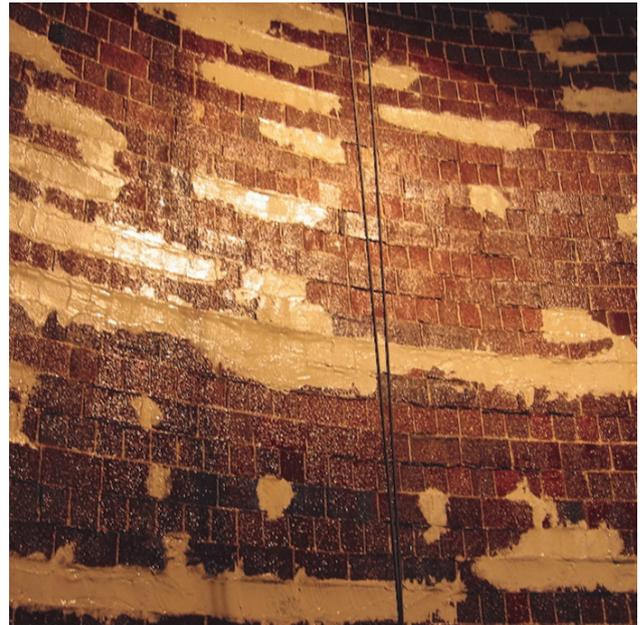
Picture 2: 2003, Brick flue before Penn-guard lining

The installation of the Penn-guard lining took place in Octo-ber 2003 in unit 1 and in March 2004 in unit 2 (see pic-tures 2 - 5).

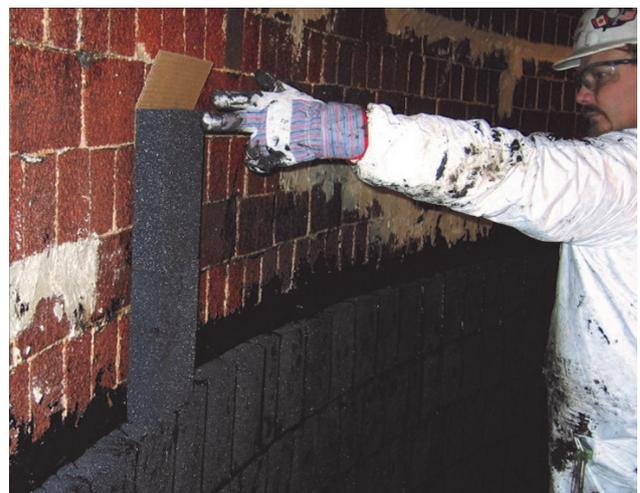
Picture 3: Penn-guard lining application onto irregular brick surface.

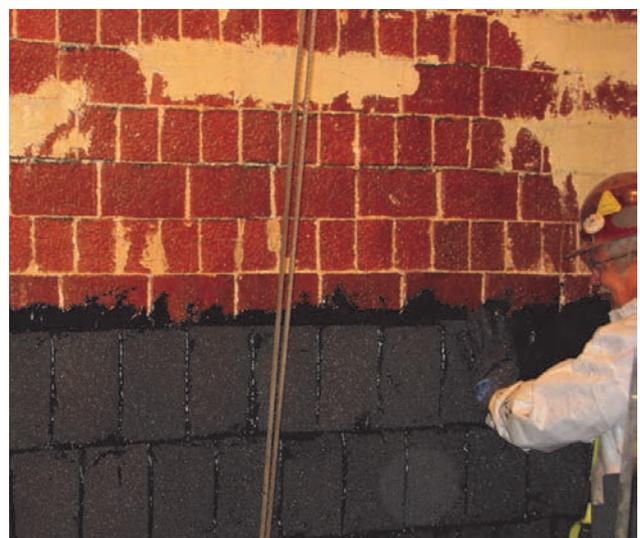
Picture 4: Penn-guard lining installation

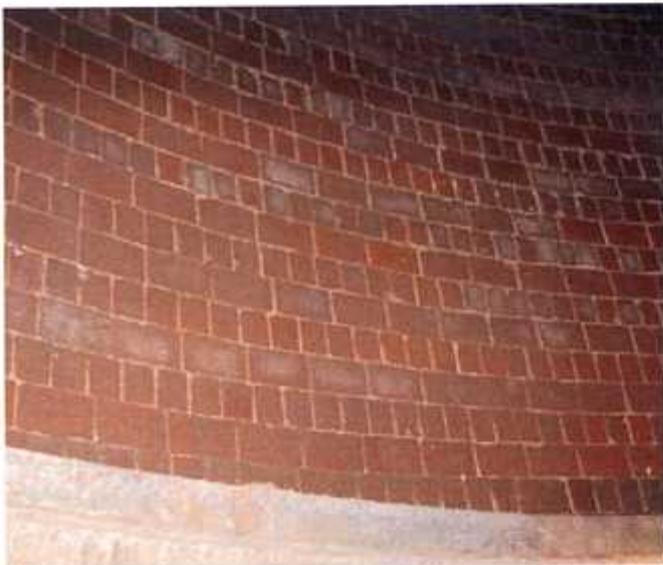
**Picture 6: Height 65 m, in-side flue at liquid collection gutter level.**

**Ter-mi-na-tion of Penn-guard Block Lin-ing Sys-tem**

After more than two years of operation, an outage presented an opportunity to inspect the chimney flue on the outside and inside. The inspection proved that the Penn-guard Block Lining System completely closes off the substrate from the flue gas and condensates that is running down the inside of the flue continuously.

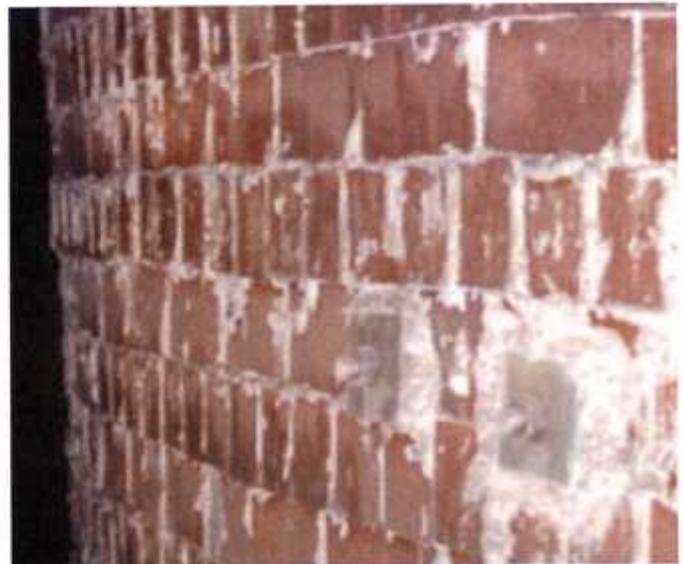
**Picture 7: Height 29 m, outside of flue, annular space at floor level.**

**Shown bolts are false floor supporting bolts**

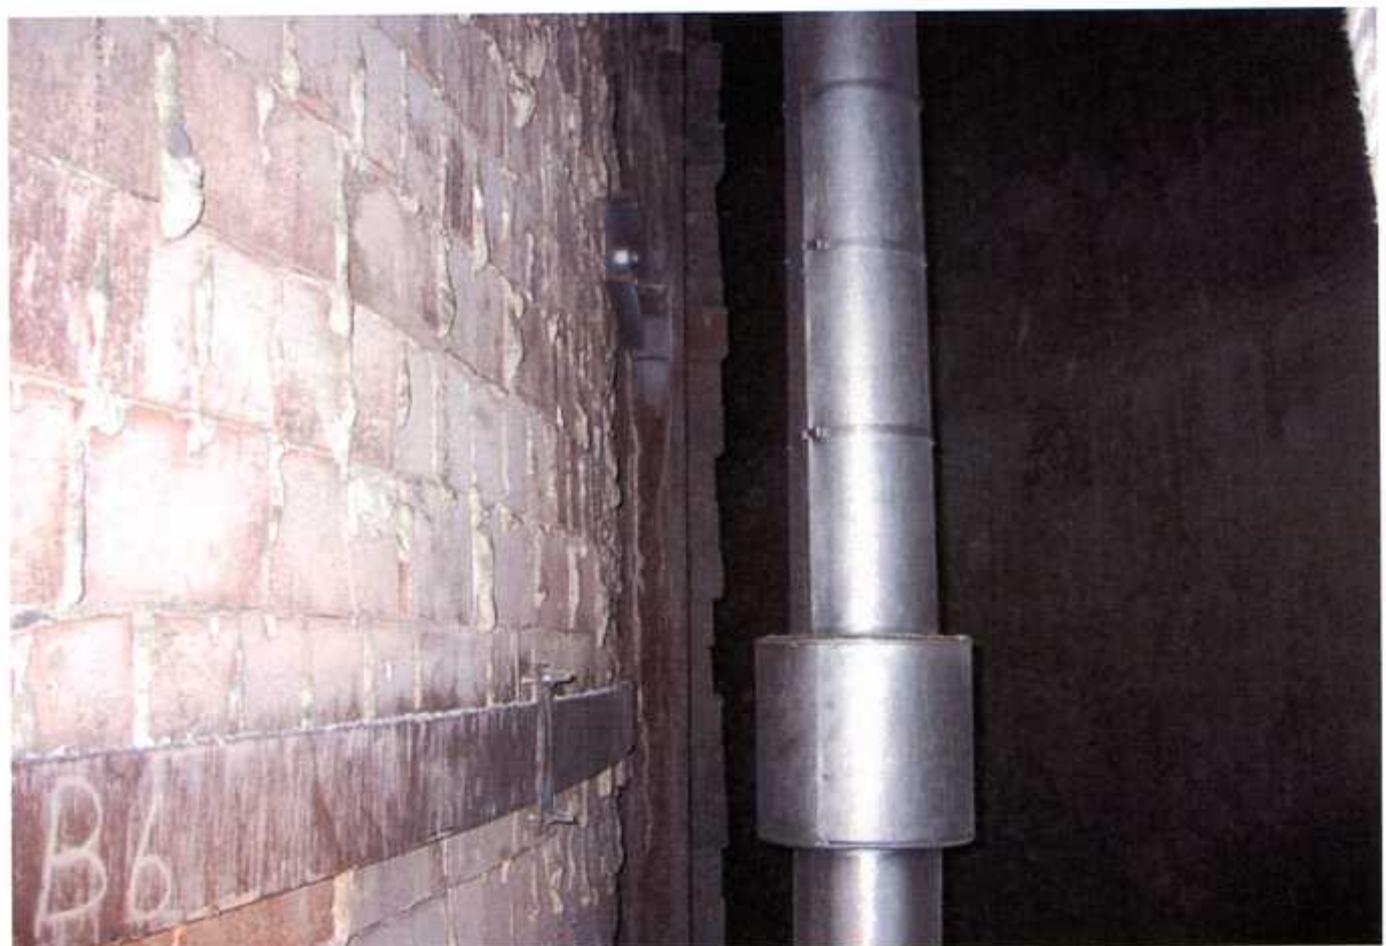
**Picture 8: Height 46 m, outside flue, annular space, mid Pennguard lining level**

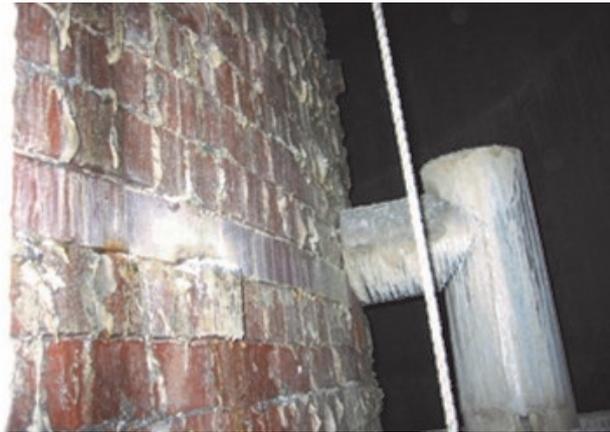
**Picture 9: Height 65 m, outside flue, an-nu-lar space at top of liq-uid col-lec-tion drain**

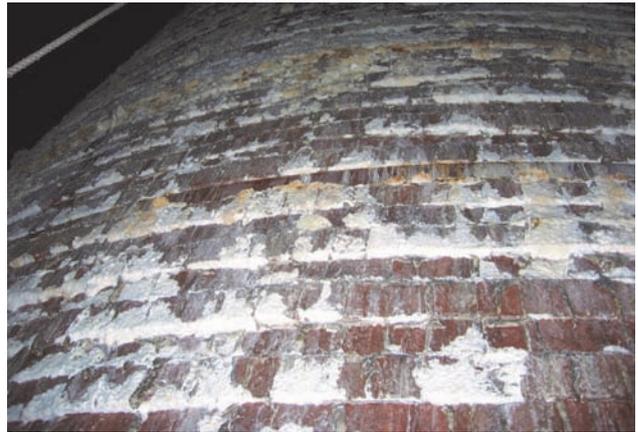
**Picture 10: Height 65 m, outside flue, annular space, beyond top of Pennguard lining level, look-ing up from 65 m**

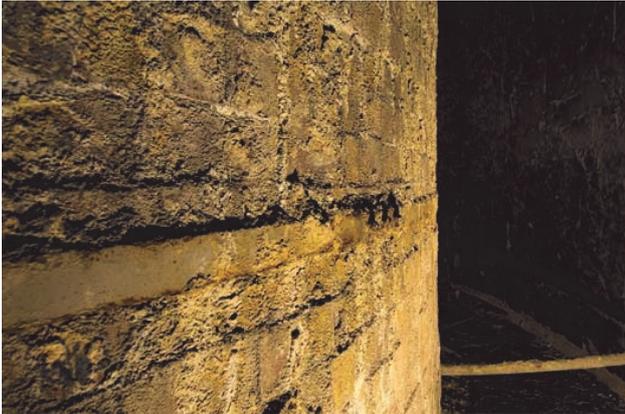
**Picture 12: Acid condensate attacked all steel reinforcement bands as well as the concrete foundation**

In case of the Dallman chimney, this permeation had become a continuous maintenance issue, since the acidic condensate in

the annular space corroded ladders and platforms including the steel bands that hold the independent brick flue together (picture 12). On the concrete foundation, residual sulfuric salts were building up, attacking the concrete underneath. A permanent solution to this problem was found in closing the brick flue off from the flue gas and its condensates by applying the Pennguard Block Lining System on the inside of the brick flue. The Pennguard lining was installed in 5 weeks (pictures 13 – 15). After one year of operation, an inspection showed that the outside of the brick flue is now completely dry (pictures 16 – 17).

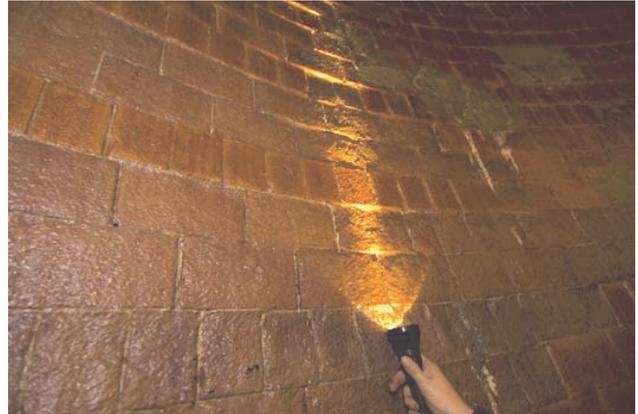
**Picture 13: Pennguard linings can easily adapt to offsets**

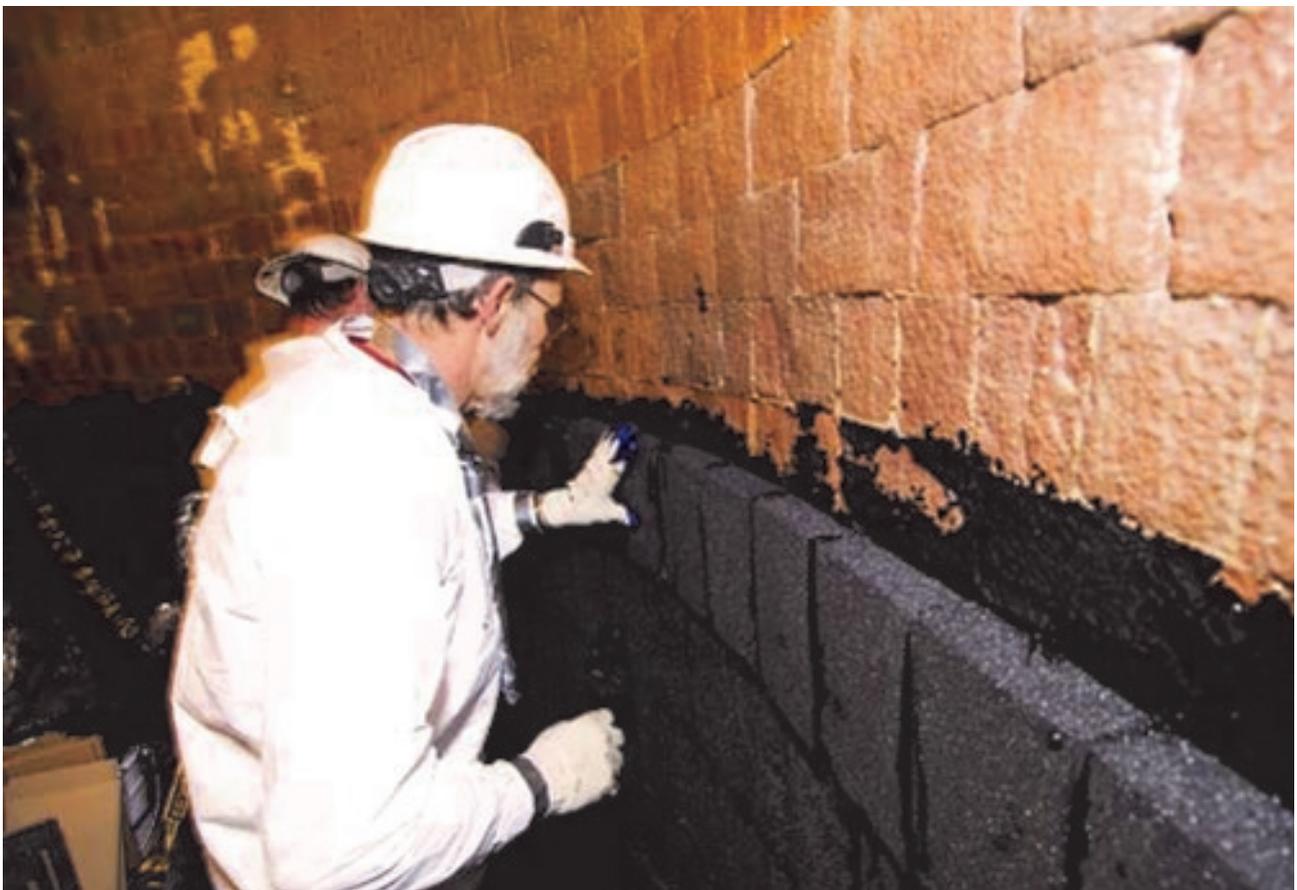
**Picture 14: Pennguard lining application**

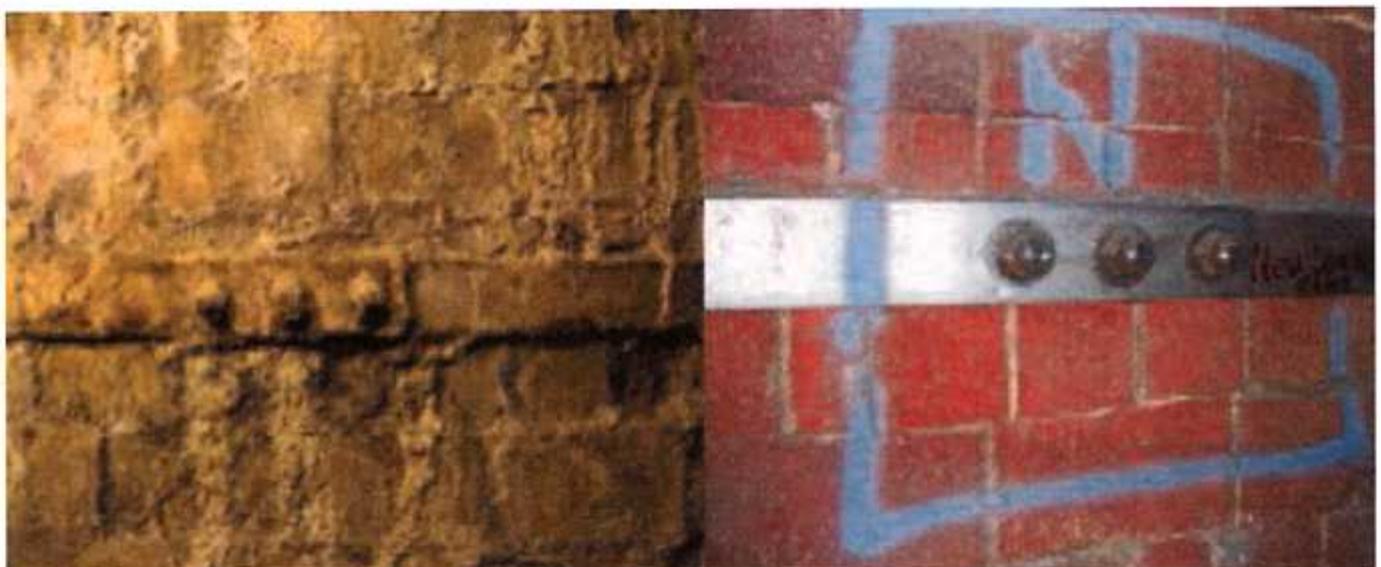
Pictures 16, 17: Outside of the flue after one year of operation without Pennguard lining (left) and with an internal barrier (right)

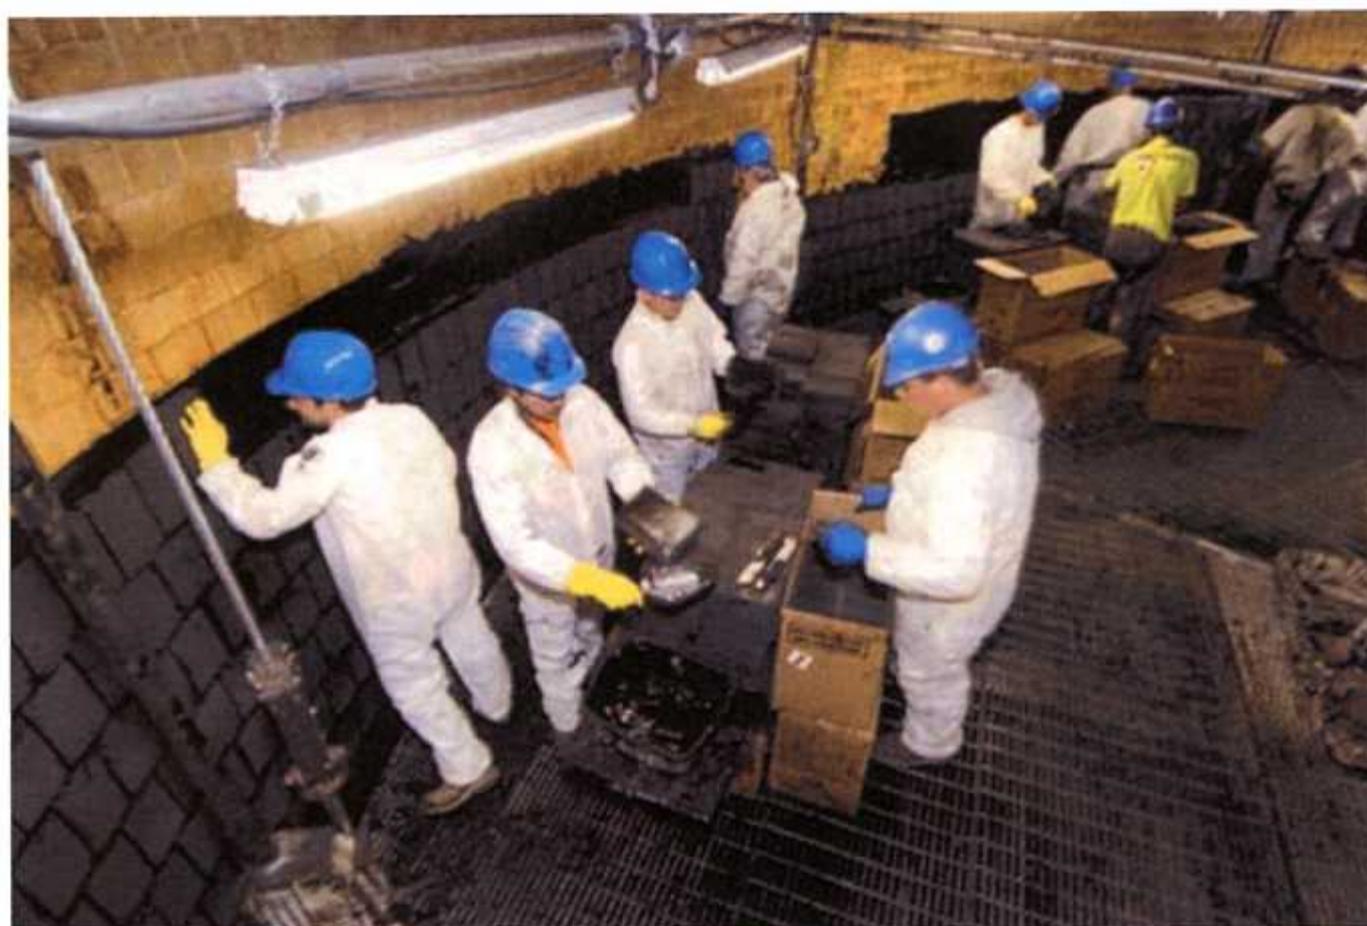
**Picture 19: 15 bricklayers per shift applying the lining system**

Following pictures (19 – 22) are showing the Pennguard lining application.

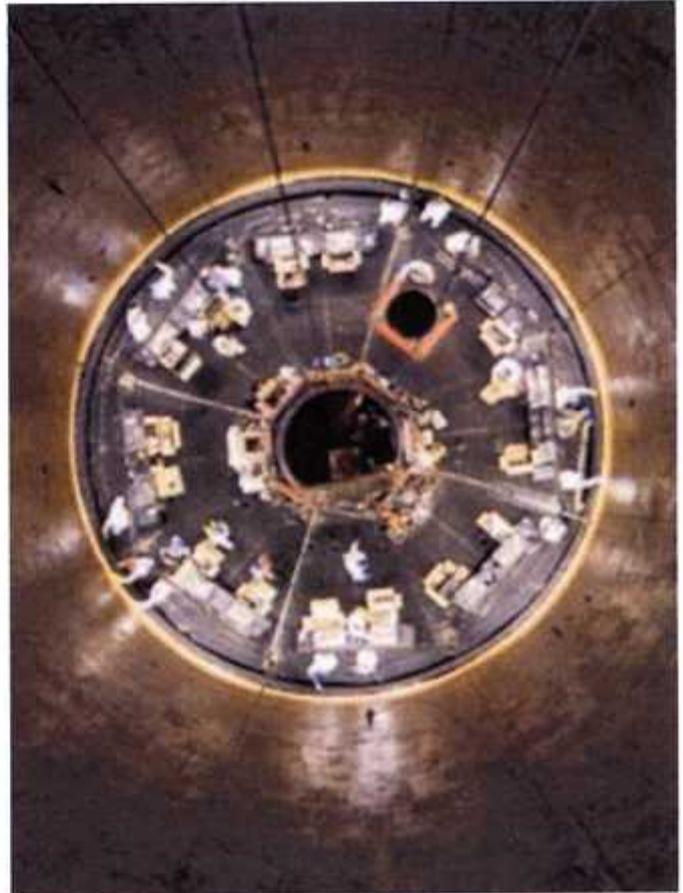
Picture 21: Lower platform  
(max chimney flue ID is 16 m)

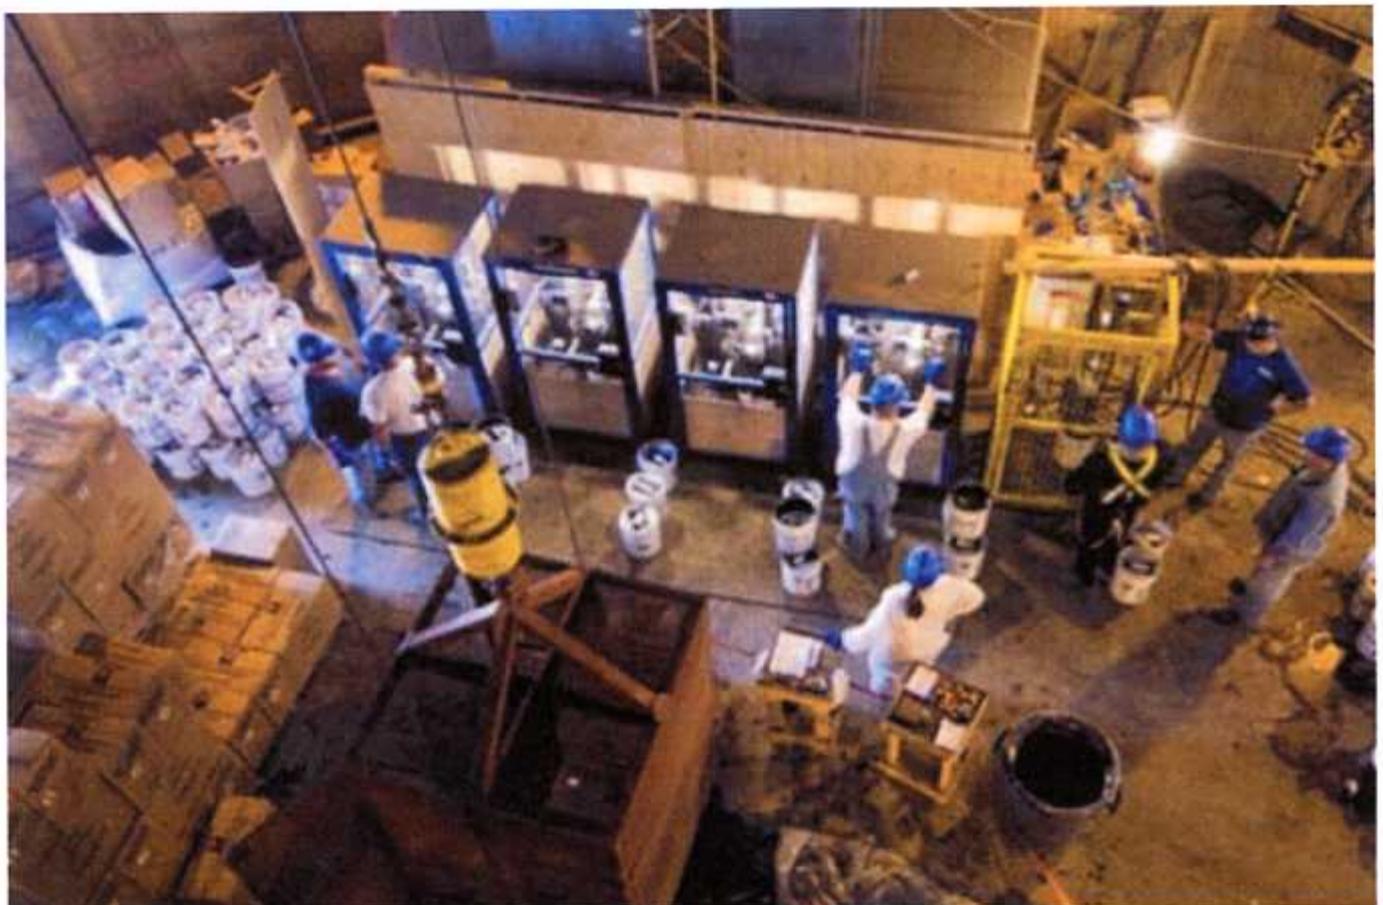
Picture 22: Five Pennguard Adhesive Membrane mixing machines were used for the job
