Power Station Amercentrale 9 modifies its brick lining for “Wet Stack” operation

1. Introduction

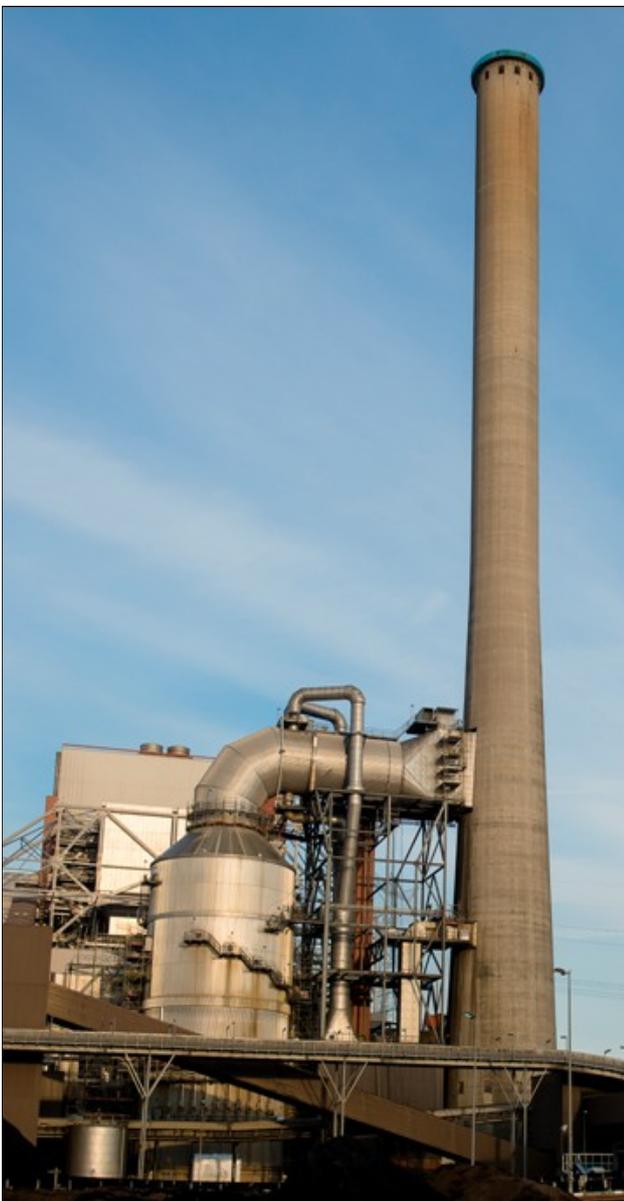
Figure 3: 181 m high chimney Unit 9. Inlet duct at 75 m.

In 1996, the Owner found an unexpected problem in the 181 m high Unit 9 chimney (figure 3). The brick liner consists of nine independent sections with an internal diameter of 8,25 m (figure 4). The 90% desulphurized flue gas was reheated to 60 °C. The flue gas enters the chimney at 75 meters above ground level, leaving the lower part of the chimney as ‘dead space’. Large amounts of acidic condensate were coming out through the brick joints into the annular space (figure 5) attacking the concrete chimney support structure.

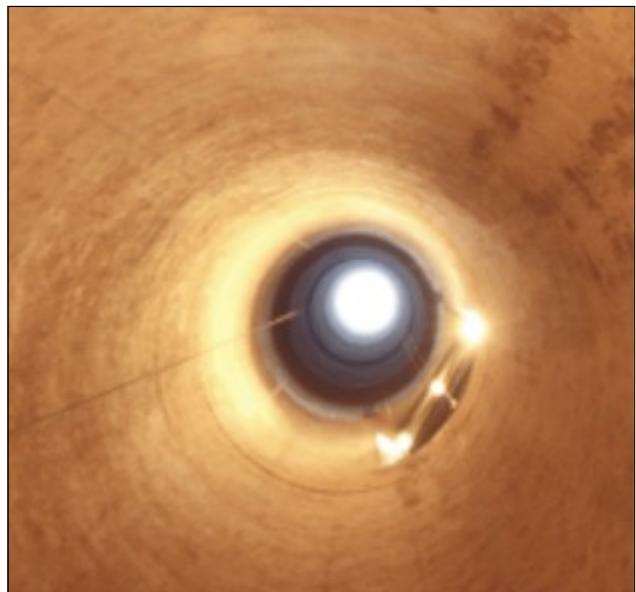
Figure 4: Inside surface of brick chimney flue.

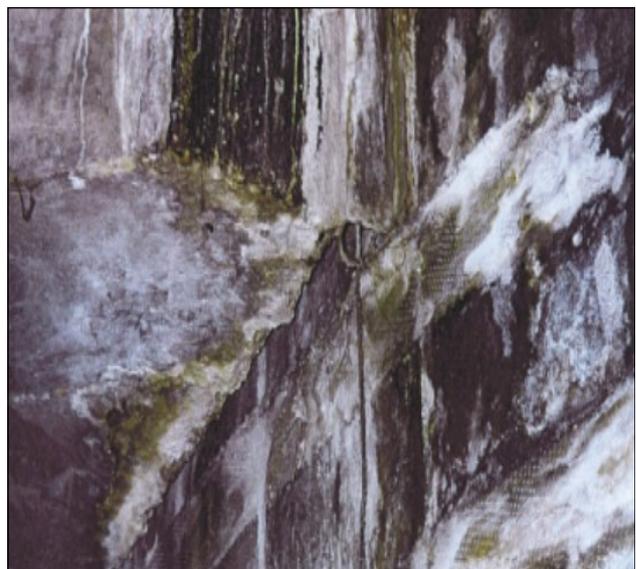
Figure 5: Acidic deposits on the outside surface of brick chimney flue.

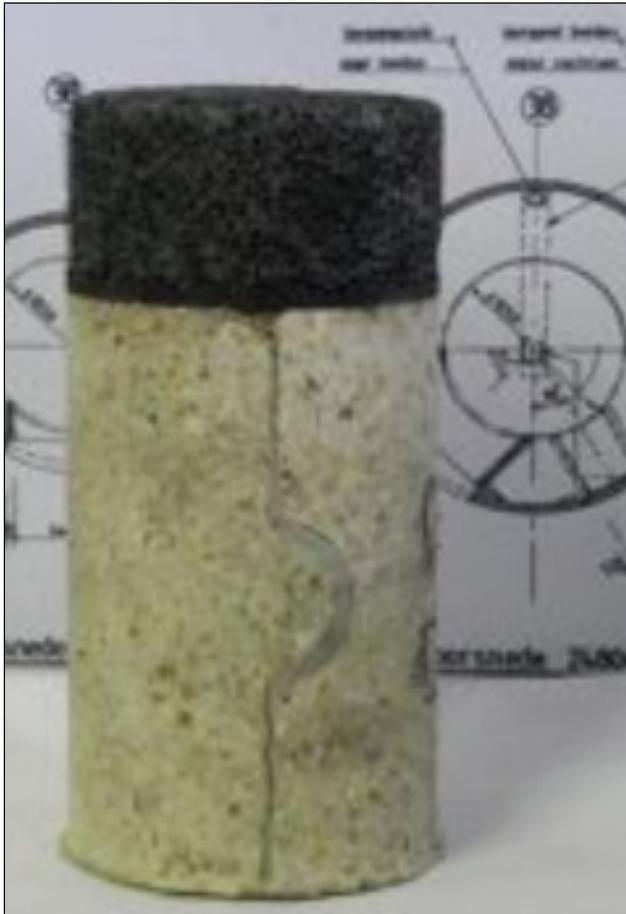
Figure 6: Core sample

After 15 years of service the Pennguard Block Lining System appears to be in excellent condition.

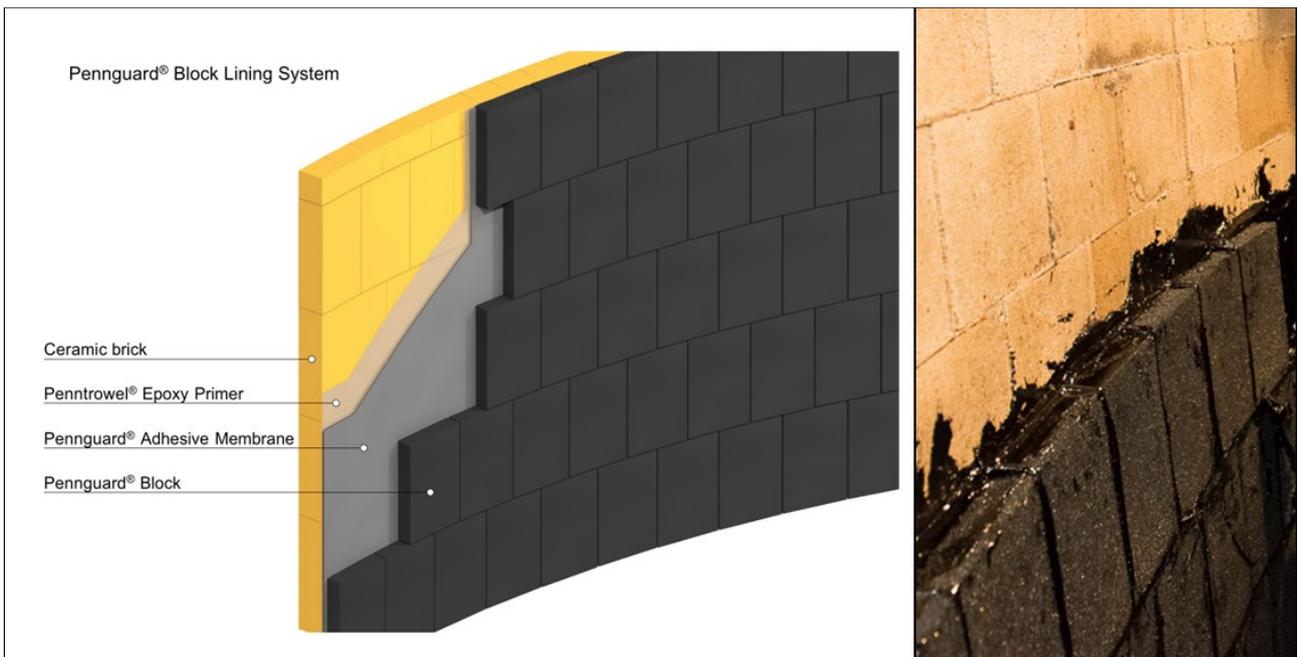
Figure 7: Cross section Pennguard Block Lining System

In 1997 the lower 75 m (1.500 m²) of the brick flue was sealed from acidic condensate with the impermeable Pennguard Block Lining System. The installation of the lining took less than 9 days.

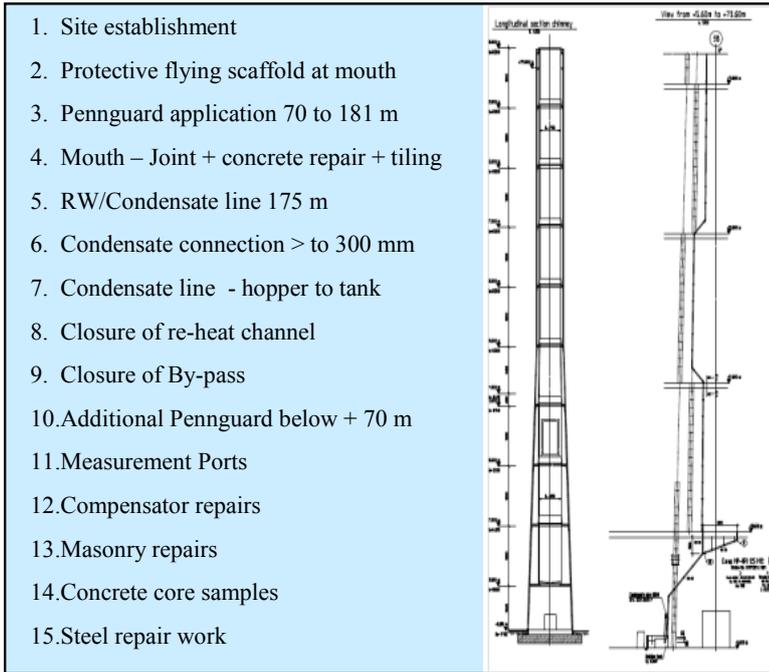
Figure 8: Work Scope

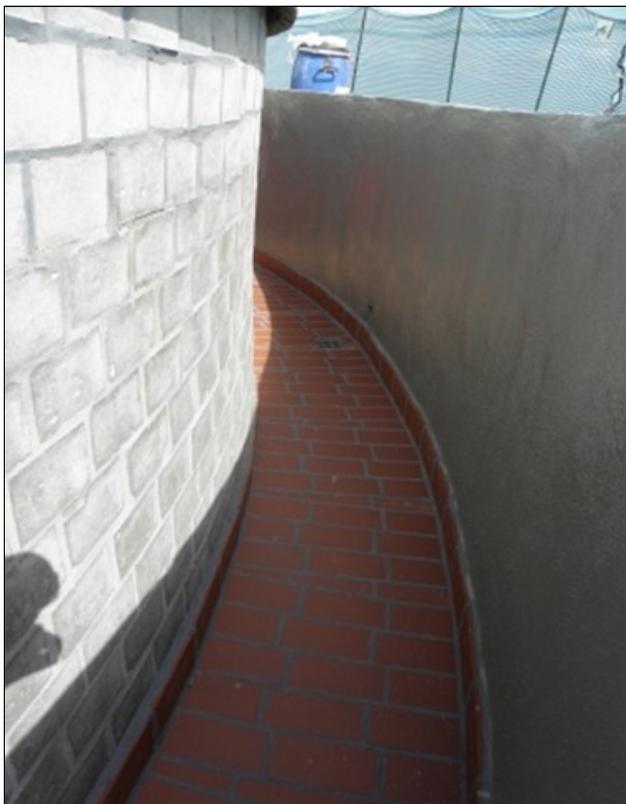
Figure 9: Mouth Slab + Parapet repair

The tickle in the project execution was to also undertake certain additional measures that became apparent – these were also discussed, defined and awarded by the Client to ensure completion within the defined period. These measures are shown on the enclosures Fig. 6 + 7 together with Fig. 8 giving an overall appraisal of work undertaken and the Fig. 9 showing the work to the mouth slab area – with Fig. 10 showing the man-cage traveling through the Pennguard tunnel.

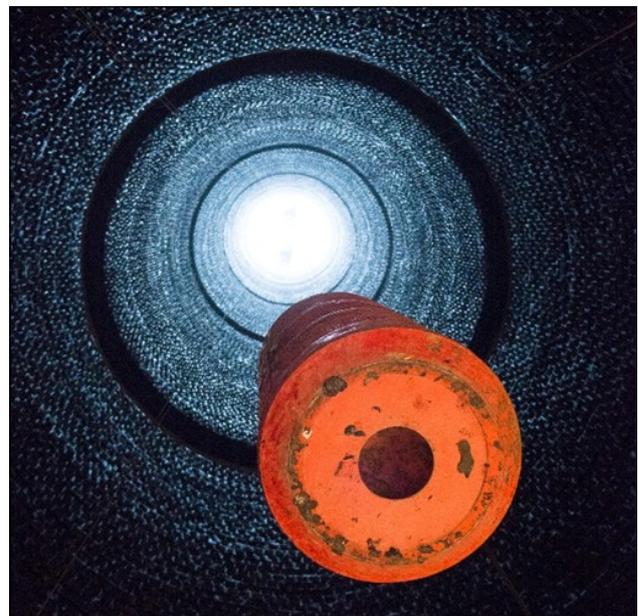
Figure 10: The black hole – Pennguard lined
