PROTECTING POWER PLANT CHIMNEYS

Key facts about Colbun 1 and Bocamina 2 Power Stations

Two new coal fired power stations in Chile use New Chimney Design and find their chimneys undamaged after strong earthquake.

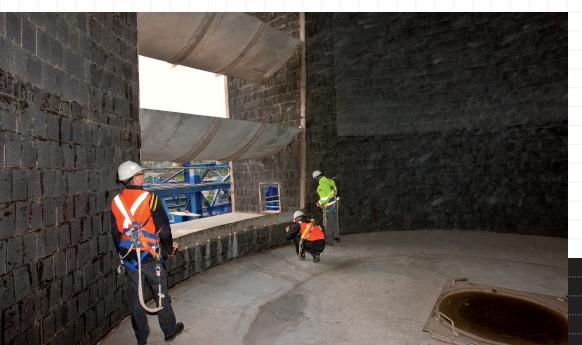
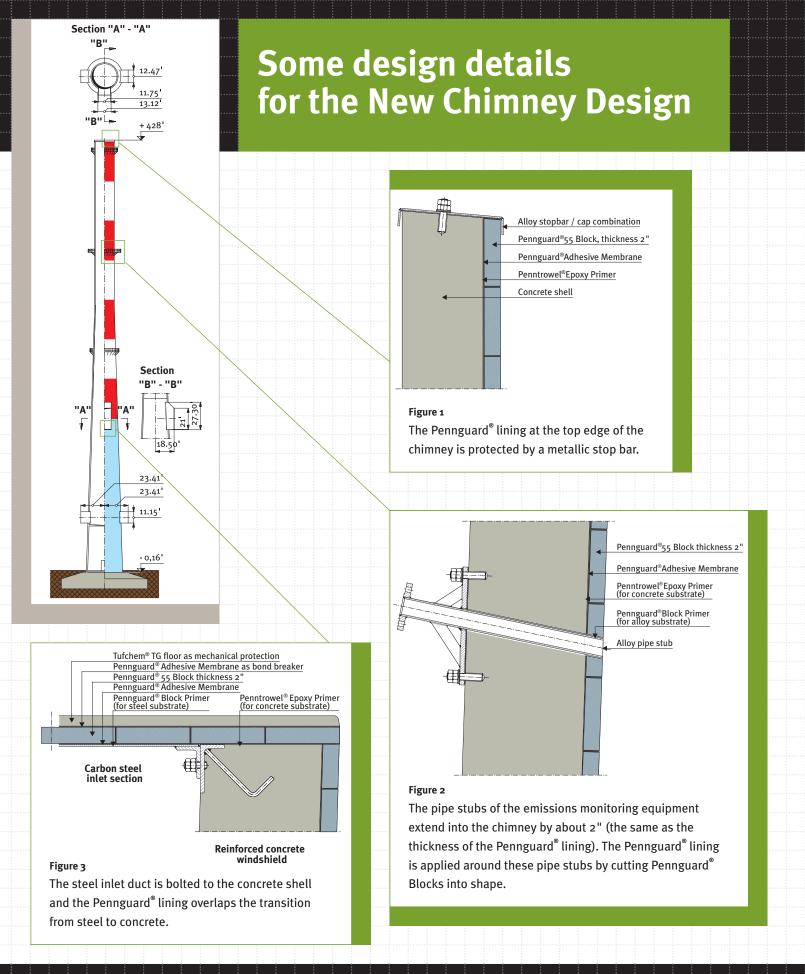
After their arrival in Chile in May 2010, the team first visited Professor Ernesto Cruz to become familiar with the seismic design of the Colbun and Bocamina chimneys. The team then performed site visits and inspected the chimneys, finding that both chimneys were in excellent condition. Any cracks found in the chimneys were narrow and less than 0.008".

The Pennguard® linings of both chimneys were also completely intact, except for some localized, minimal cracking near the chimney inlet ducts.
