Project REPORT

Amercentrale power station

Pennguard® seals and protects leaking brick chimney liner

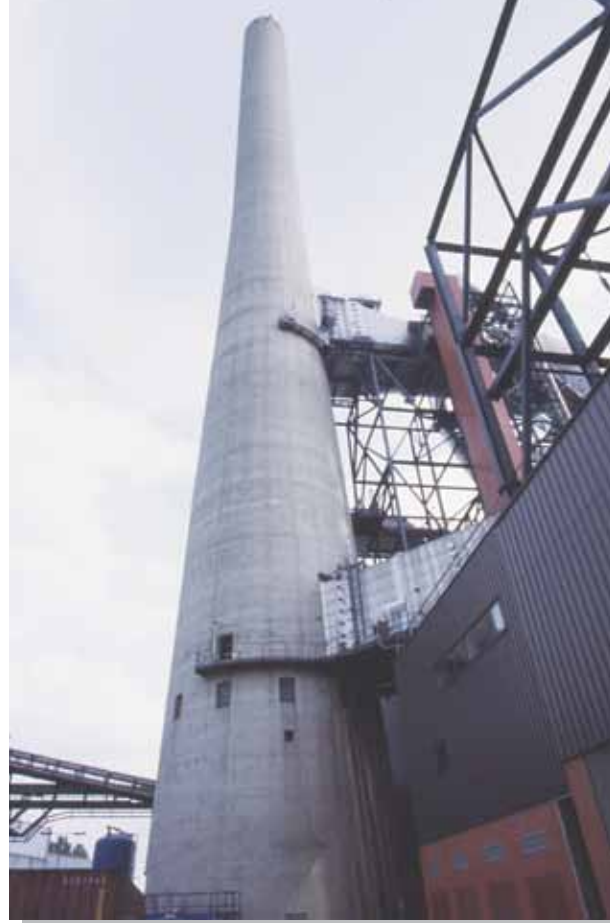
The chimney of Amercentrale, Unit 9.

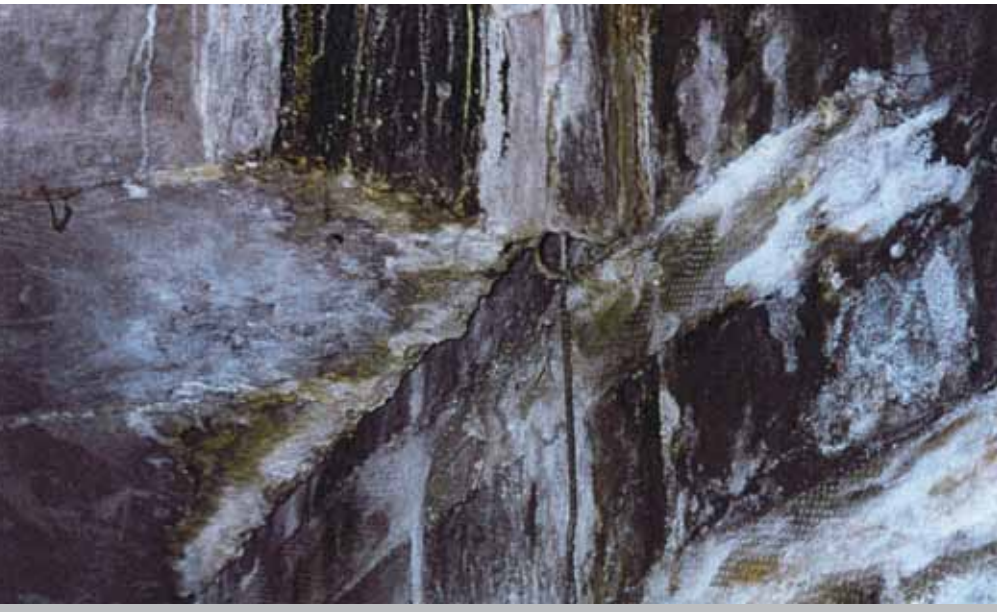
Acidic deposits on the outside of the brick flue.

This explains why the permeation of the ceramic brick was by far the worst in the lower three sections. A thorough inspection of the chimney showed, that large amounts of acidic condensate

were coming out through the brick joints into the annular space. The acid then ran down the outside of the brick, behind the insulation, and gathered on the concrete support structure in highly acidic

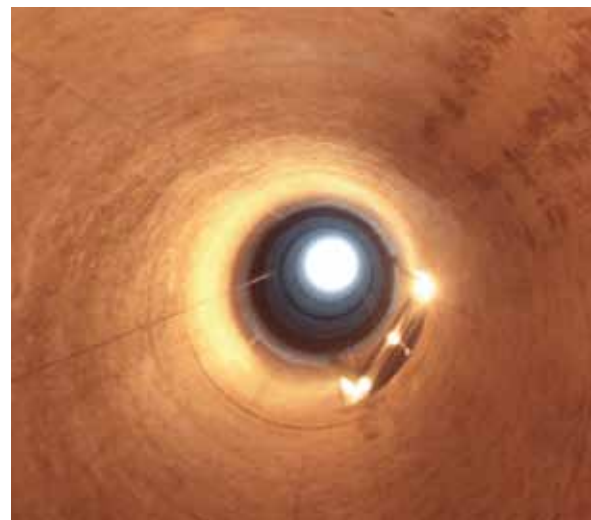
Inside view of the brick flue.

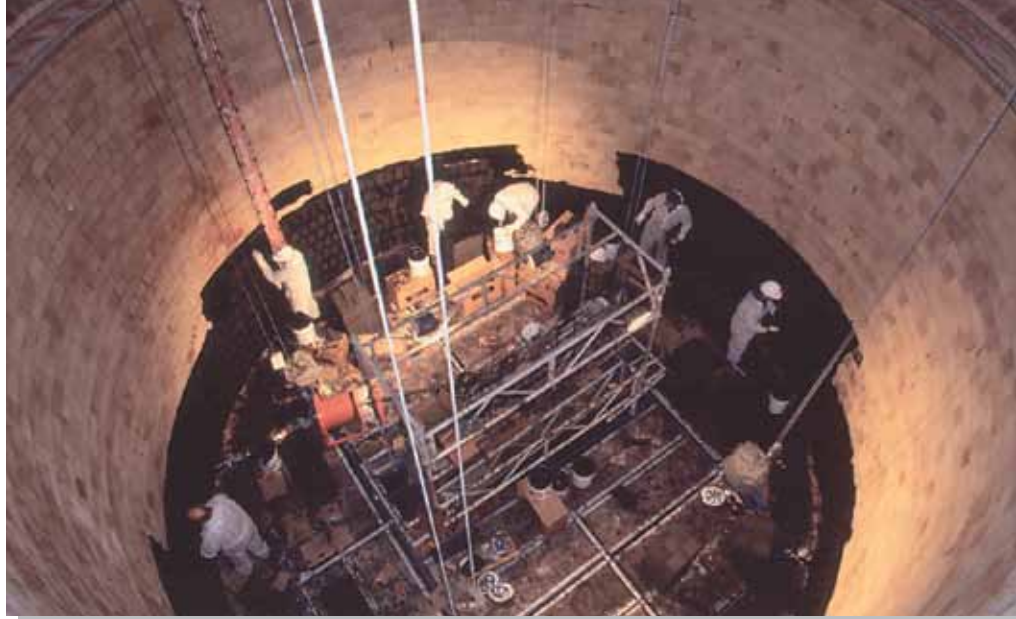
All work in the chimney was done from a movable work platform.

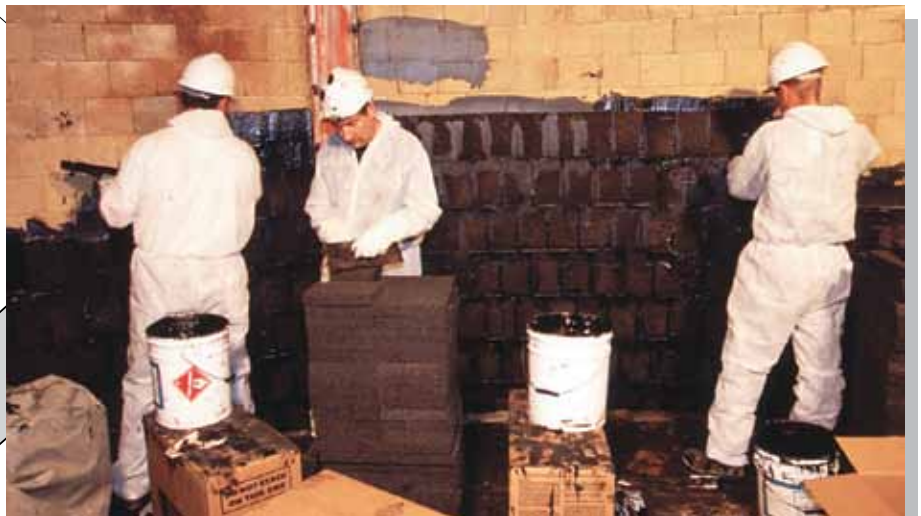
Experienced brick layers apply the Pennguard® lining.

When installing a Pennguard® lining on a ceramic brick surface, the substrate is first grit blasted in order to remove all dirt, deposits and other loose particles. Then, if the surface is sufficiently dry, an epoxy sealer, Penntrowel® Epoxy Primer, is applied using roller and brush.

The installation of the Pennguard® lining itself is the work of experienced brick or tile layers. In the case of this project, a group of 17 applicators came over from England to do the job.

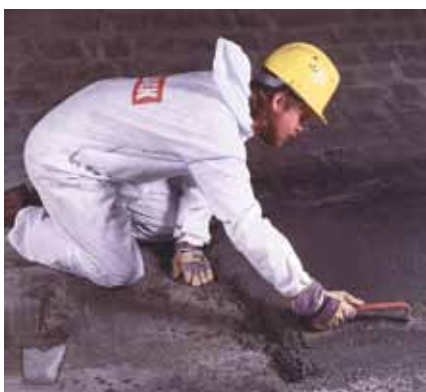
The chimney floor receives an additional layer of acid resistant cement.
