Project REPORT

Craiova power station

Romanian power station modifies concrete chimney using Pennguard® Block Lining System

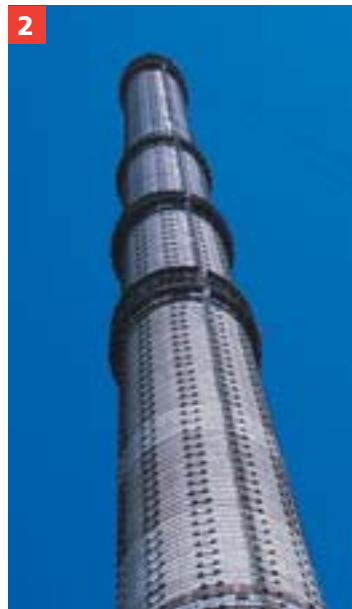
2

In order to reduce and control the width of the cracks in the 200 m concrete windshield, the contractor placed a system of high strength steel bands around the outside of the chimney.

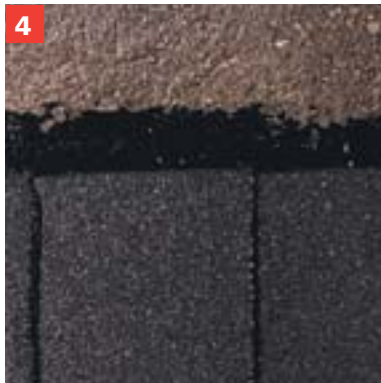
4

Following the repair work on the concrete shell, the contractor installed Pennguard® linings directly onto its internal surface, to protect the concrete from acid condensate as well as from high temperature and thermal shock.

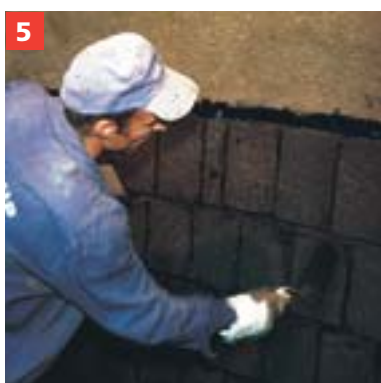
6

In order to protect the concrete shell from operating temperatures of up to 165 °C, the chimney uses Pennguard® Blocks in thicknesses of 3,0, 2,5 and 2,0 inches. The total weight of the Pennguard® lining system in the chimney is 95 tons.

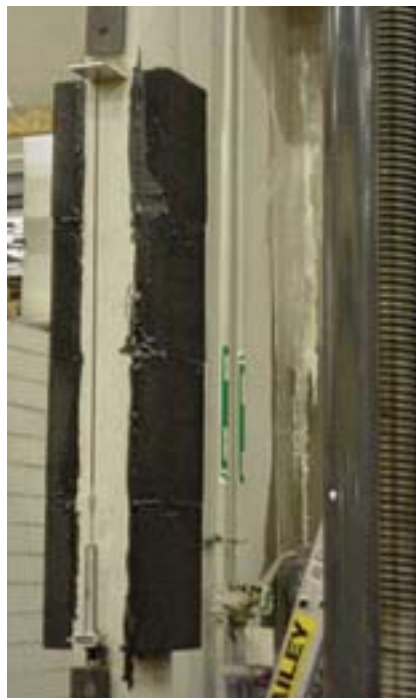
General test set-up

The laboratory prepared large slabs of reinforced concrete, with Pennguard® linings attached to them and exposed these to the same forces and movements that would be expected for a large chimney during a strong earthquake. The study found, that for tensile strains of up to 1 percent,

with formation of 0,8 mm wide cracks, the Pennguard® lining did not sustain any damage, even though the concrete shell itself would require repair after such an event.

During extreme earthquake conditions with up to 3 % tensile strain, (a typical "once in 500+ years" event), the Pennguard® Blocks did crack at the locations of the cracks in the concrete, but the adhesion of the lining to the concrete remained intact.
