**HADEK**

PROTECTING POWER  
PLANT CHIMNEYS

## Rybnik Power Station

# Fast and effective restoration of corroded steel chimney flues

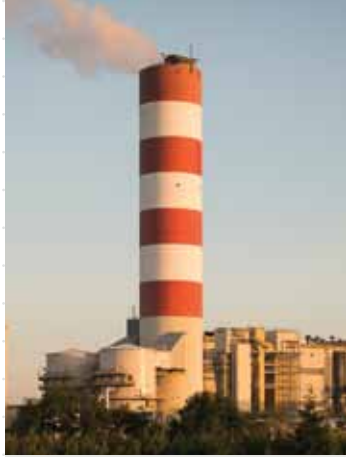
FGD wet stack with two steel flues

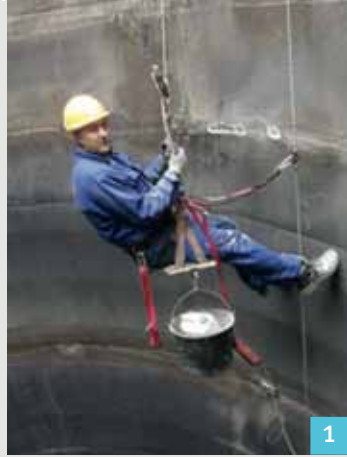
Repair of corroded steel areas

Where severe corrosion and holes had occurred, the damaged area was grit blasted and the holes were closed off by welding on appropriately sized steel plates.

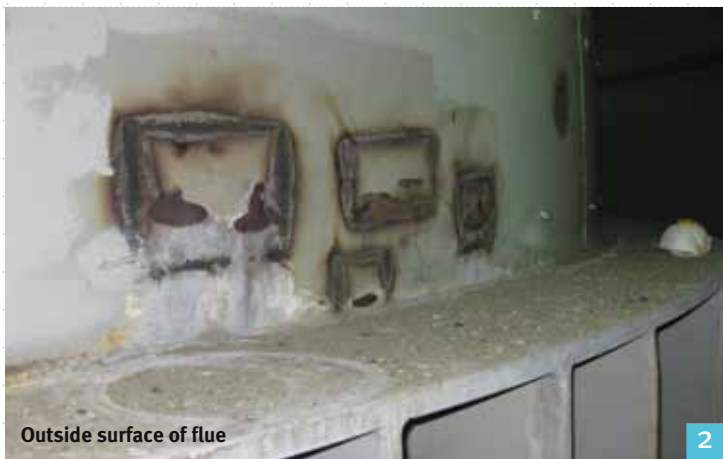
Outside surface of flue

Holes in the flue caused by acid dewpoint corrosion. The holes were repaired by welding new steel plates and protecting these with a new coating on the inside surface of the flue.

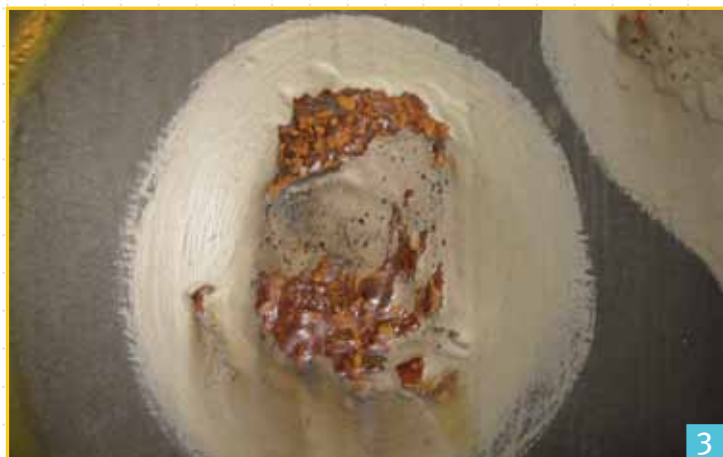
Corroded spots repaired with new coating, corroded again

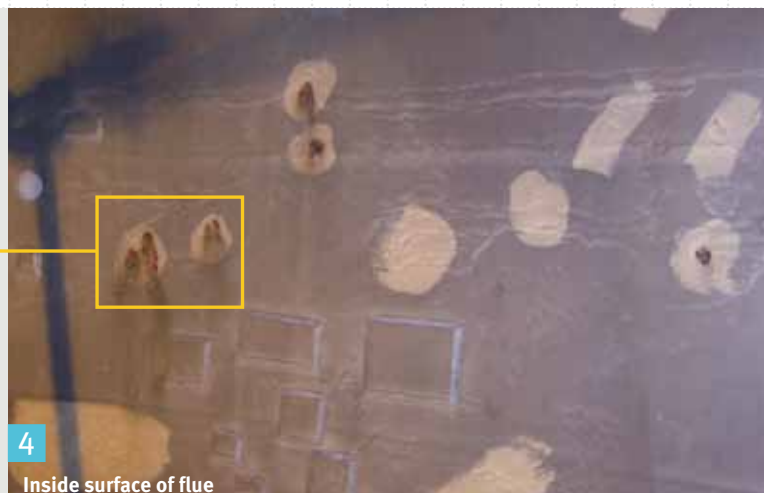
Inside surface of flue

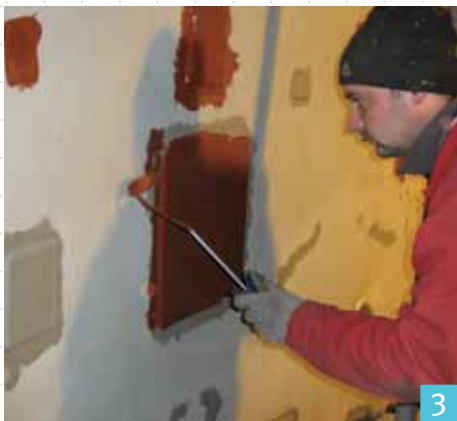
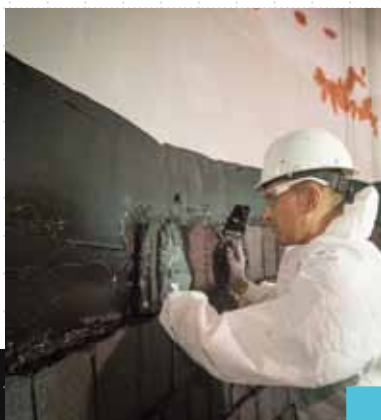
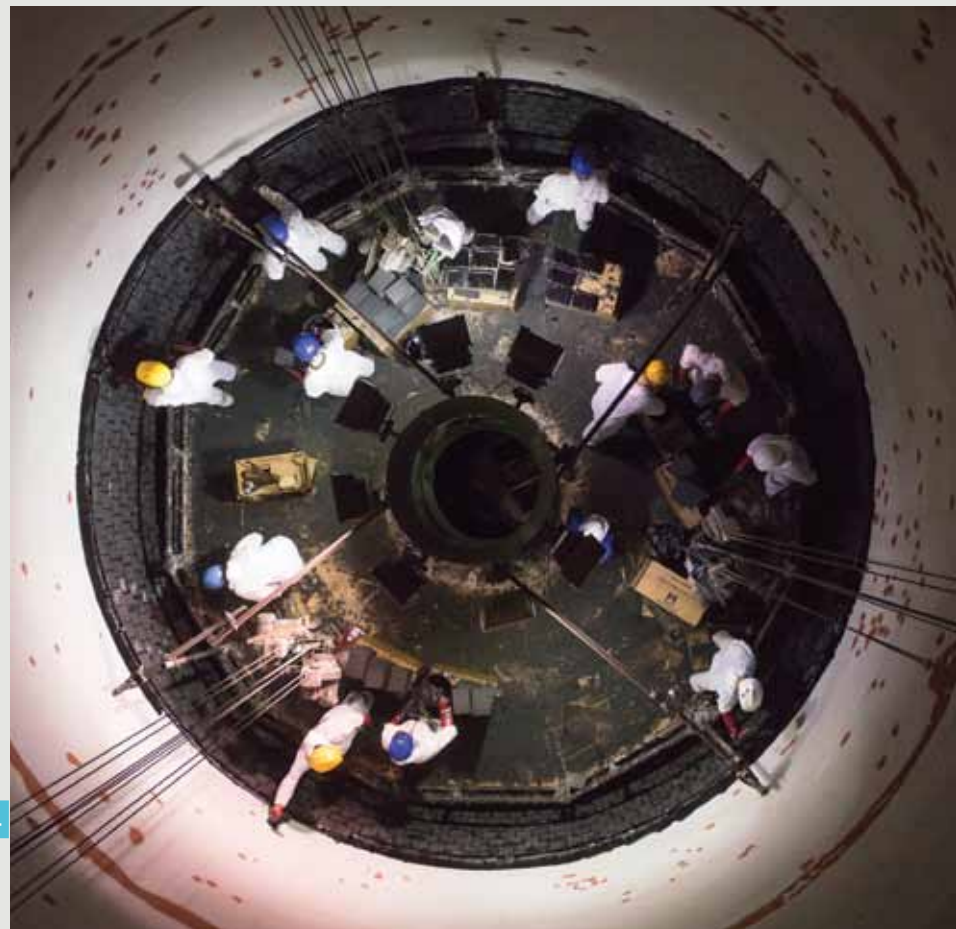
The Pennguard® lining was installed using a suspended work platform, by teams of 11 brick layers including support workers working in 2 shifts of 10 hours each. The total surface area within each flue is 1.793 m<sup>2</sup> and both flues were repaired and relined within a 36-day unit outage.

The Pennguard® lining installations in the two flues, in 2012 and 2013, were performed successfully by Uniserv S.A., under the technical supervision of Hadek. In both flues, the work consisted of the following steps.
